**Project Name:** DIUK-1021\_02 St Marys Gate, Derby CCTV Report  
**Job Status:** Complete  
**Project Date:** 10/05/2018  
**Project Standard:** MSCC4 Sewers & Drainage GB (SRM4 Scoring)

# Drain Inspect UK

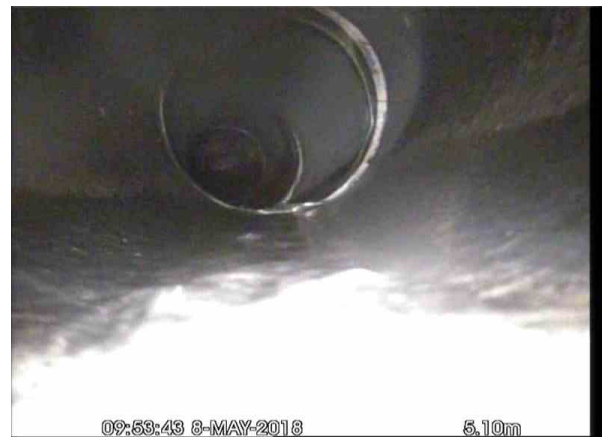
, 00:00:51, 4.34 m  
 Crack, circumferential at joint from 7 o'clock to 12 o'clock

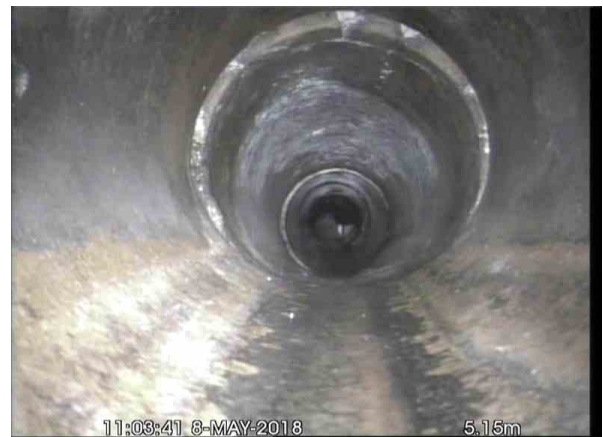
, 00:00:28, 3.85 m  
 Fracture, longitudinal at 6 o'clock

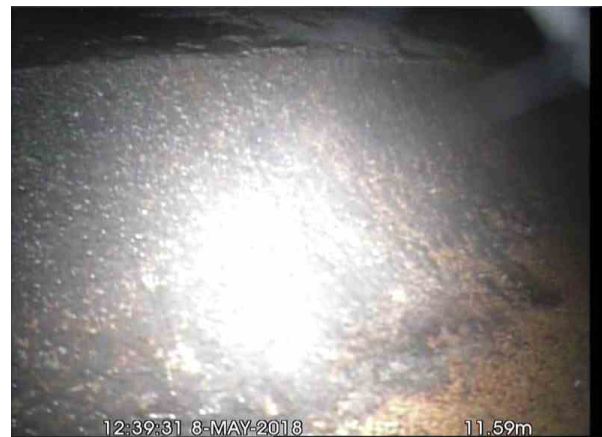
, 00:00:57, 10.21 m  
 Crack, circumferential at joint from 12 o'clock to 9 o'clock

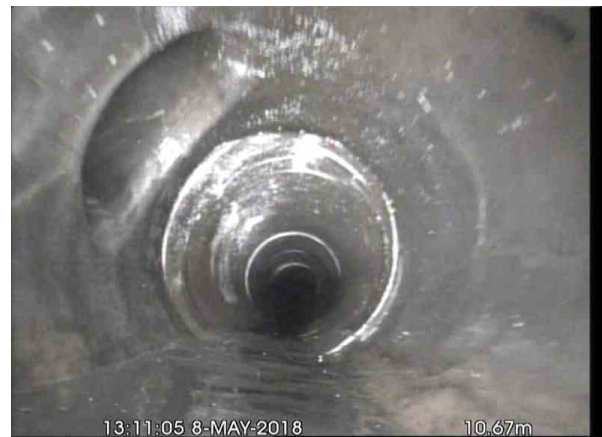
, 00:00:41, 8.22 m  
 Crack, circumferential at joint from 12 o'clock to 12 o'clock

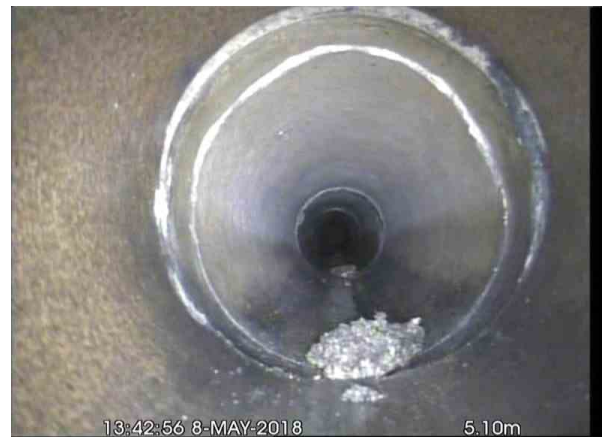
, 00:00:28, 3.33 m  
 Attached deposits, other at joint from 12 o'clock to 12 o'clock,  
 5% cross-sectional area loss

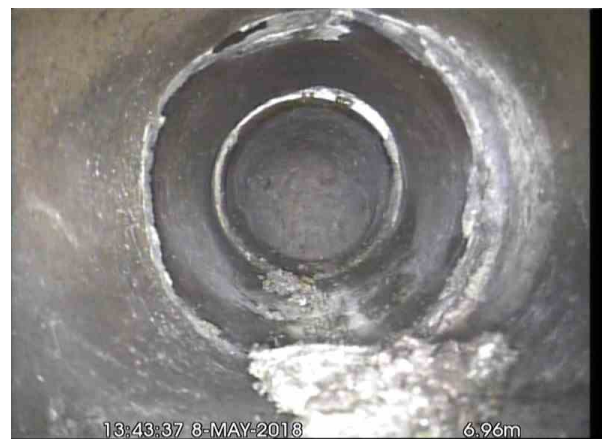
, 00:01:09, 6.28 m  
 Crack, circumferential at joint from 12 o'clock to 12 o'clock
