**Project Name:** DIUK-1021\_02 St Marys Gate, Derby CCTV Report  
**Job Status:** Complete  
**Project Date:** 10/05/2018  
**Project Standard:** MSCC4 Sewers & Drainage GB (SRM4 Scoring)

# Drain Inspect UK

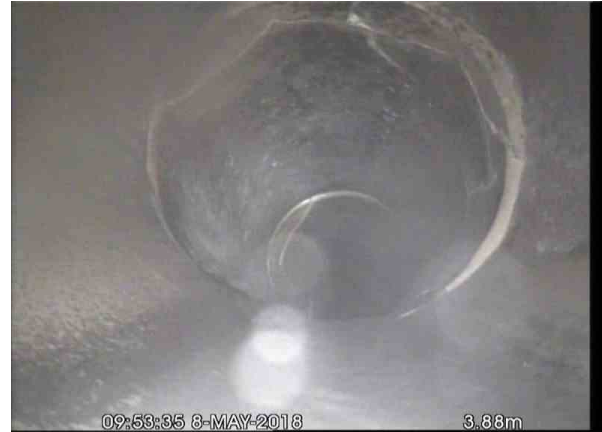
| Scale: 1:70 | Position [m] | Code | Observation | MPEG | Photo | Grade |
|---|---|---|---|---|---|---|
| | 3.88 | CMJ | Cracks, multiple at joint from 9 o'clock to 3 o'clock | 00:00:48 | | 3 |

, 00:00:48, 3.88 m  
 Cracks, multiple at joint from 9 o'clock to 3 o'clock

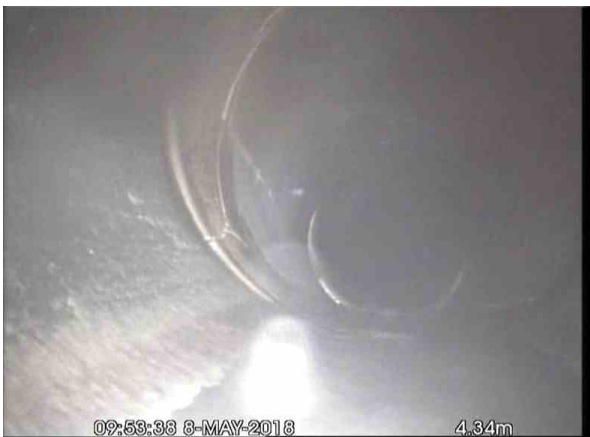
| Scale: 1:70 | Position [m] | Code | Observation | MPEG | Photo | Grade |
|---|---|---|---|---|---|---|
| | 4.34 | CCJ | Crack, circumferential at joint from 7 o'clock to 12 o'clock | 00:00:51 | | 2 |

, 00:00:51, 4.34 m  
 Crack, circumferential at joint from 7 o'clock to 12 o'clock

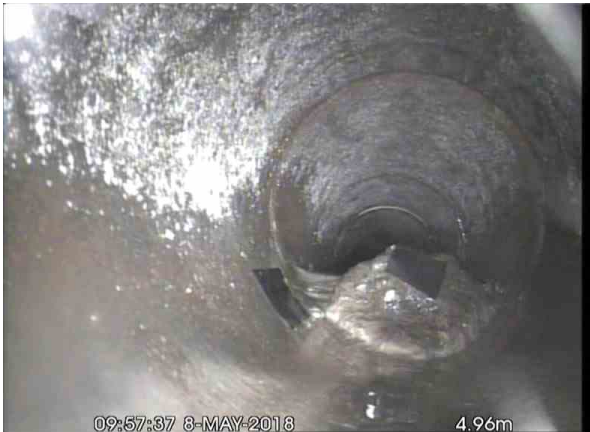
, 00:00:37, 4.96 m  
 Settled deposits, hard or compacted at joint, 10% cross-sectional area loss

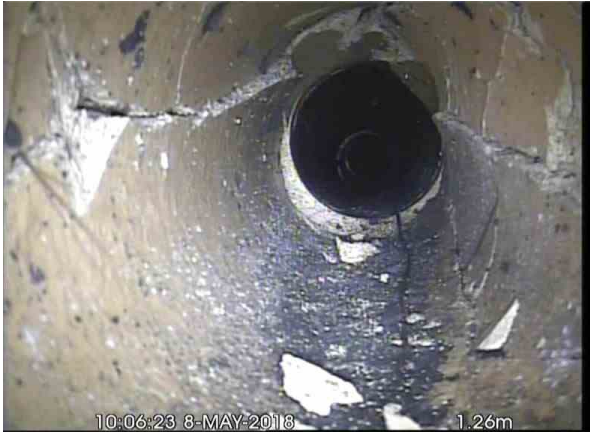
, 00:00:11, 1.26 m  
 Broken pipe from 9 o'clock to 3 o'clock

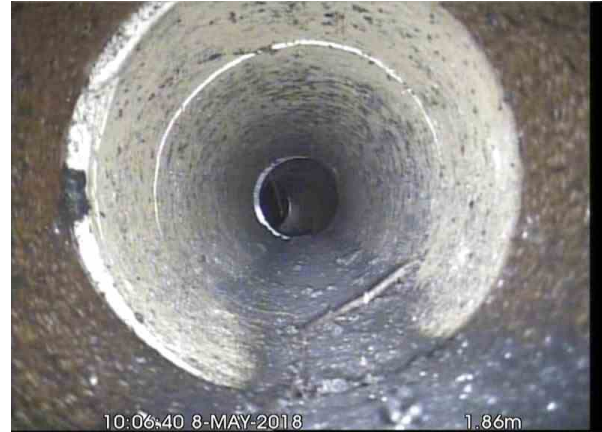
, 00:00:28, 1.86 m  
 Crack, circumferential at joint from 12 o'clock to 12 o'clock

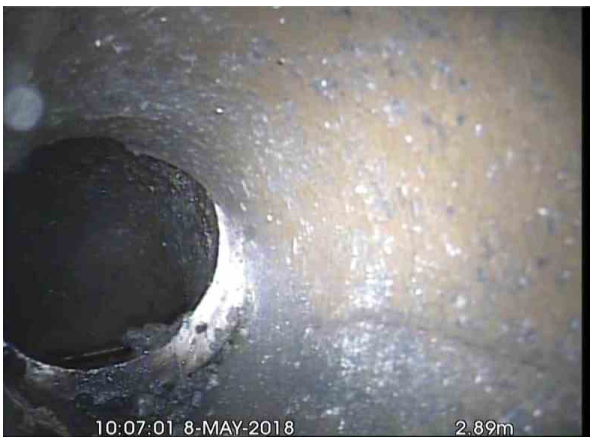
, 00:00:49, 2.89 m  
 Joint displaced, medium

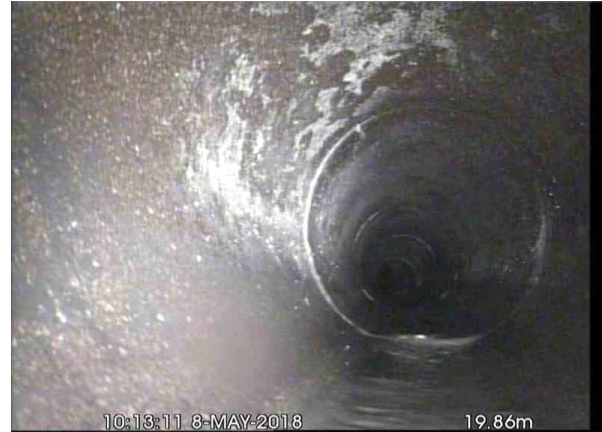
, 00:02:49, 19.86 m  
 Survey abandoned, Unable to push camera any further

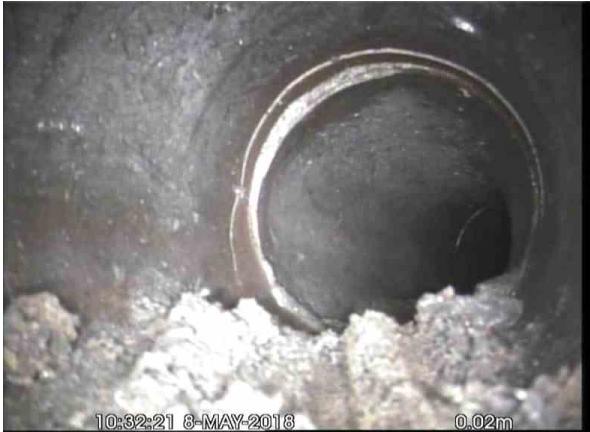
, 00:00:03, 0.02 m  
 Crack, circumferential at joint from 12 o'clock to 12 o'clock

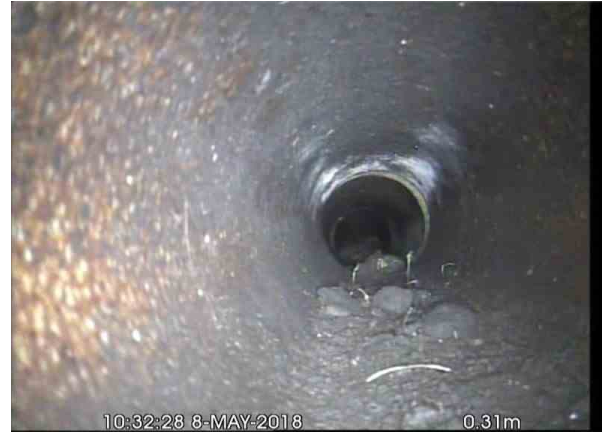
, 00:00:10, 0.31 m  
 Settled deposits, fine, 5% cross-sectional area loss, start

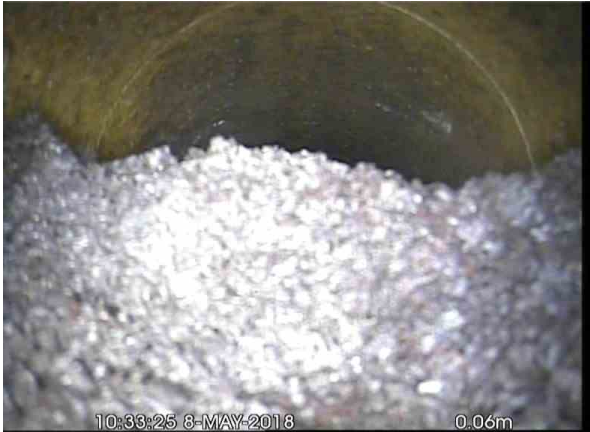
, 00:00:01, 0.06 m  
 Settled deposits, fine, 40% cross-sectional area loss, start

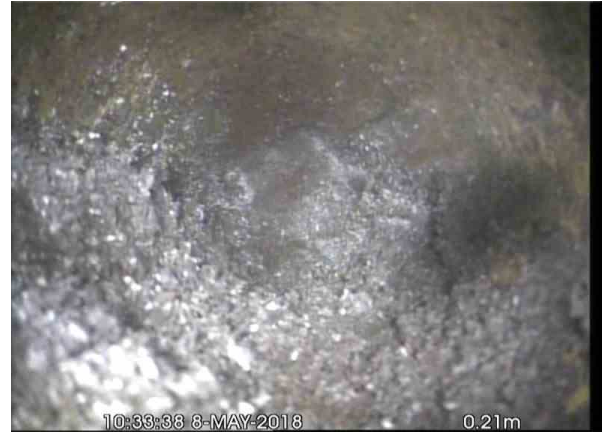
, 00:00:15, 0.21 m  
 Survey abandoned, Unable to pass debris

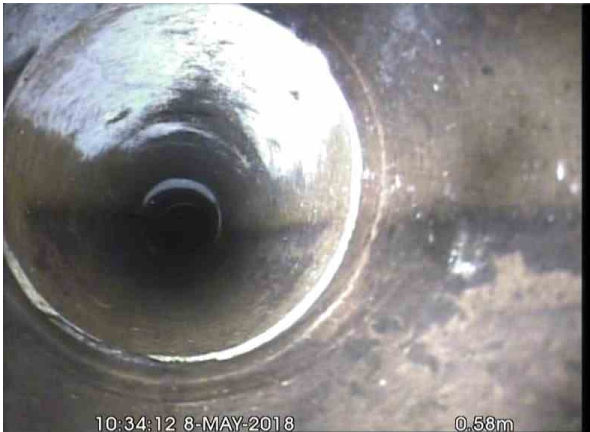
, 00:00:09, 0.58 m  
 Crack, circumferential at joint from 12 o'clock to 12 o'clock

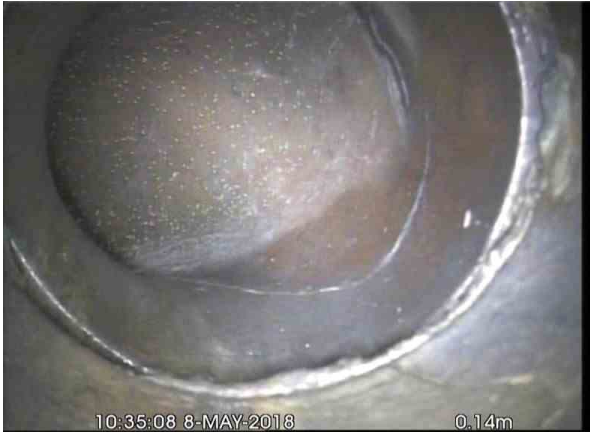
| Section | Inspection Direction | PLR | Client's Job Ref | Contractor's Job Ref |
|---|---|---|---|---|
| 8 | Upstream | | | DIUK-1021 |

| Scale: 1:50 | Position [m] | Code | Observation | MPEG | Photo | Grade |
|---|---|---|---|---|---|---|
| | 0.14 | CCJ | Crack, circumferential at joint from 12 o'clock to 7 o'clock | 00:00:04 | | 2 |

, 00:00:04, 0.14 m  
 Crack, circumferential at joint from 12 o'clock to 7 o'clock

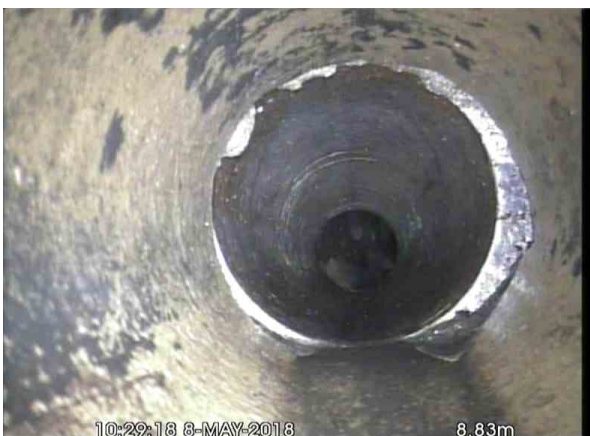
, 00:01:05, 8.83 m  
 Joint displaced, medium

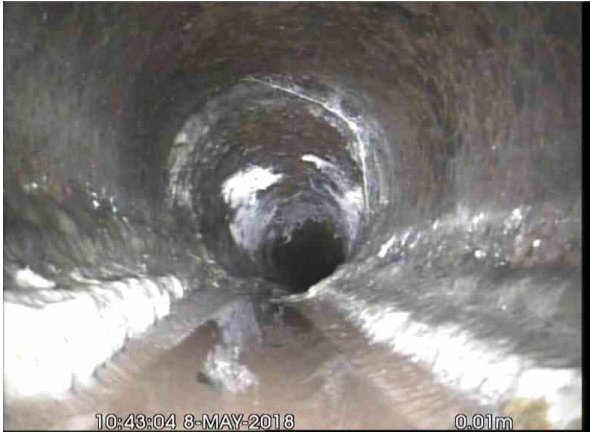
, 00:00:02, 0.01 m  
 Attached deposits, grease from 4 o'clock to 8 o'clock, 5%  
 cross-sectional area loss, start

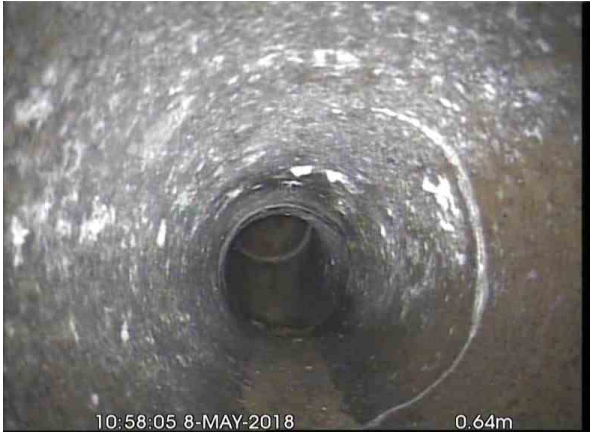
| Section | Inspection Direction | PLR | Client's Job Ref | Contractor's Job Ref |
|---|---|---|---|---|
| 15 | Upstream | | | DIUK-1021 |

| Scale: 1:50 | Position [m] | Code | Observation | MPEG | Photo | Grade |
|---|---|---|---|---|---|---|
| | 0.64 | CC | Crack, circumferential from 12 o'clock to 6 o'clock | 00:00:09 | | 2 |

, 00:00:09, 0.64 m  
 Crack, circumferential from 12 o'clock to 6 o'clock

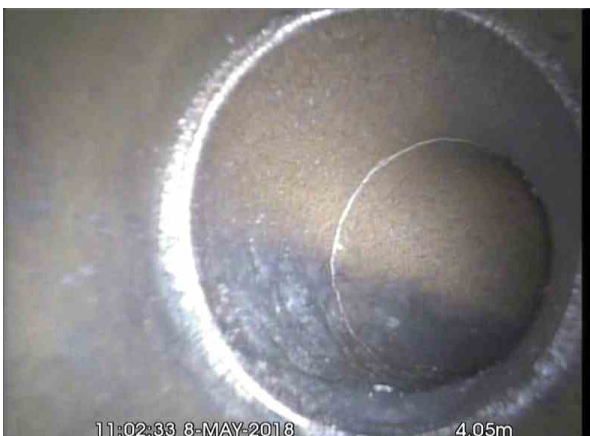
, 00:00:25, 4.05 m  
 Crack, circumferential at joint from 12 o'clock to 12 o'clock

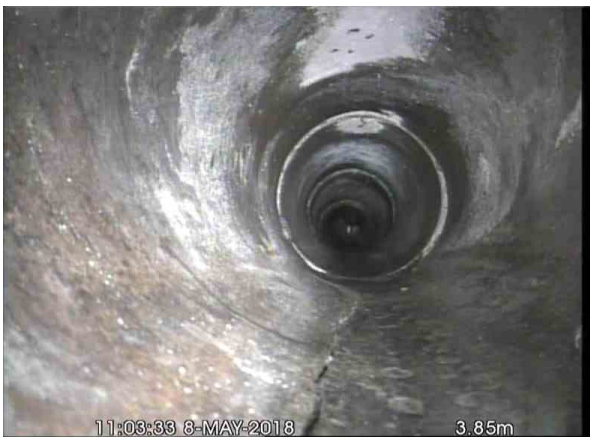
| Scale: 1:63 | Position [m] | Code | Observation | MPEG | Photo | Grade |
|---|---|---|---|---|---|---|
| | 3.85 | FL | Fracture, longitudinal at 6 o'clock | 00:00:28 | | 3 |

, 00:00:28, 3.85 m  
 Fracture, longitudinal at 6 o'clock

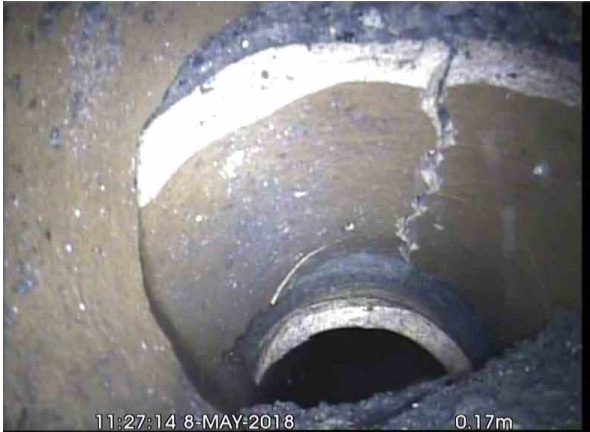
| Section | Inspection Direction | PLR | Client's Job Ref | Contractor's Job Ref |
|---|---|---|---|---|
| 20 | Upstream | | | DIUK-1021 |

| Scale: 1:50 | Position [m] | Code | Observation | MPEG | Photo | Grade |
|---|---|---|---|---|---|---|
| | 0.17 | B | Broken pipe from 10 o'clock to 2 o'clock | 00:00:06 | | 4 |
| | 0.18 | SA | Survey abandoned: Unable to pass broken pipe | | | |

, 00:00:06, 0.17 m  
 Broken pipe from 10 o'clock to 2 o'clock

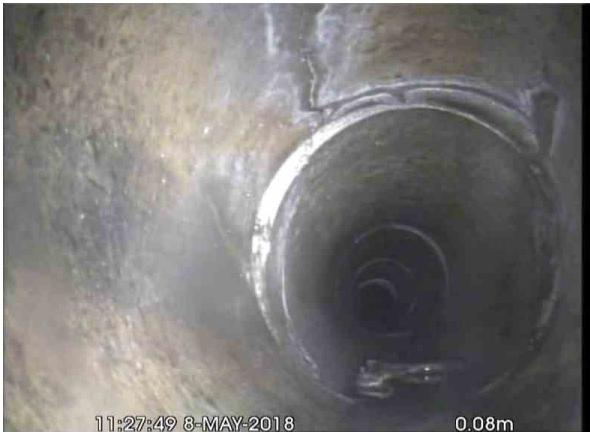
| Scale: 1:85 | Position [m] | Code | Observation | MPEG | Photo | Grade |
|---|---|---|---|---|---|---|
| 0.08 | CCJ | Crack, circumferential at joint from 7 o'clock to 1 o'clock | 00:00:05 | | | 2 |

, 00:00:05, 0.08 m  
 Crack, circumferential at joint from 7 o'clock to 1 o'clock

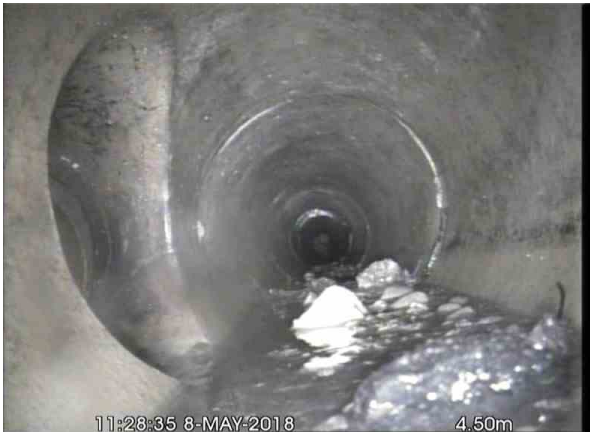
, 00:00:51, 4.50 m  
 Settled deposits, fine, 5% cross-sectional area loss

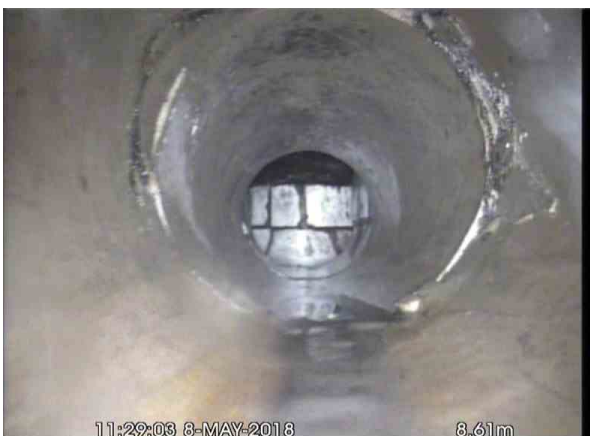
| Scale: 1:85 | Position [m] | Code | Observation | MPEG | Photo | Grade |
|---|---|---|---|---|---|---|
| 8.61 | CMJ | Cracks, multiple at joint from 11 o'clock to 4 o'clock | 00:01:18 | | | 3 |

, 00:01:18, 8.61 m  
 Cracks, multiple at joint from 11 o'clock to 4 o'clock

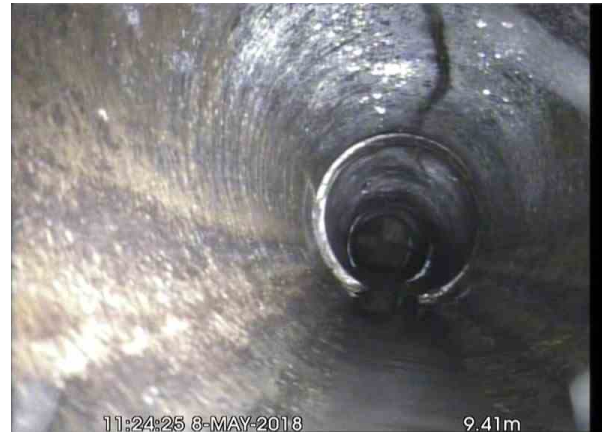
, 00:00:50, 9.41 m  
 Crack, longitudinal at 12 o'clock

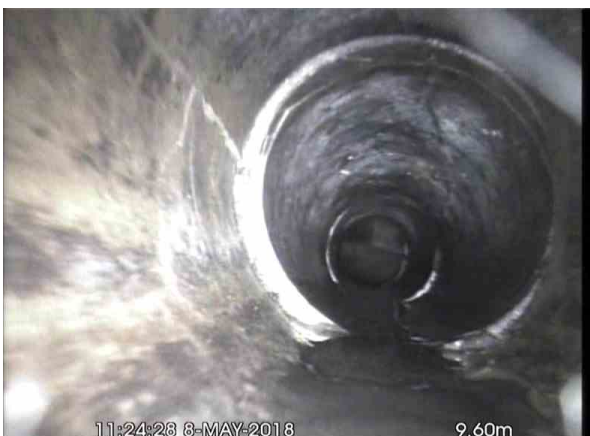
, 00:00:53, 9.60 m  
 Crack, circumferential at joint from 10 o'clock to 3 o'clock

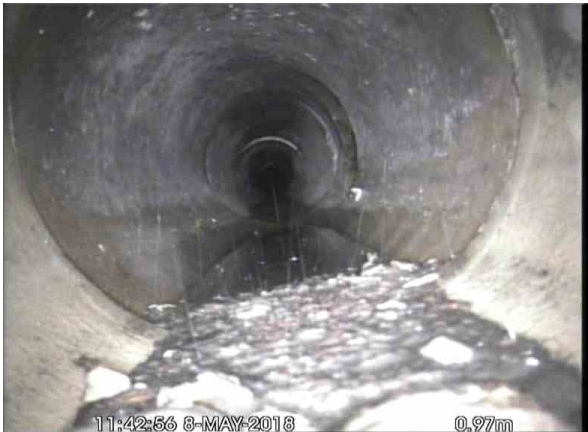
, 00:00:13, 0.97 m  
 Settled deposits, other, 5% cross-sectional area loss

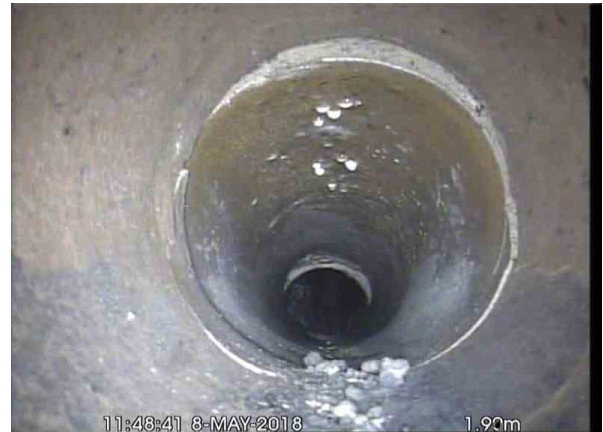
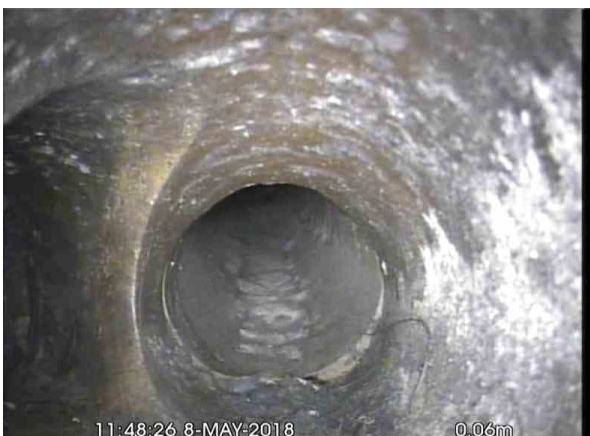
| Scale: 1:50 | Position [m] | Code | Observation | MPEG | Photo | Grade |
|---|---|---|---|---|---|---|
| | 1.90 | CCJ | Crack, circumferential at joint from 3 o'clock to 9 o'clock | 00:00:18 | | 2 |

, 00:00:18, 1.90 m  
 Crack, circumferential at joint from 3 o'clock to 9 o'clock

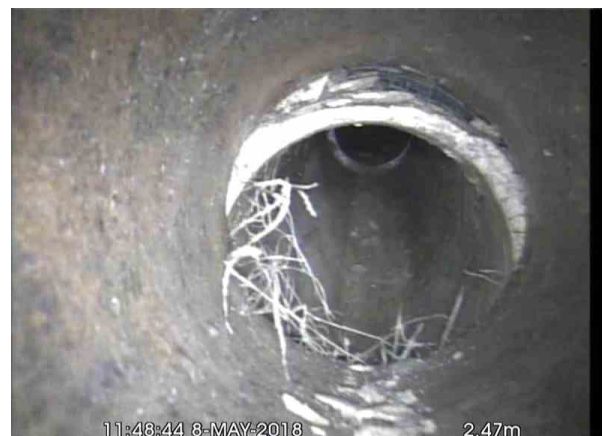
, 00:00:22, 2.47 m  
 Roots, fine at joint

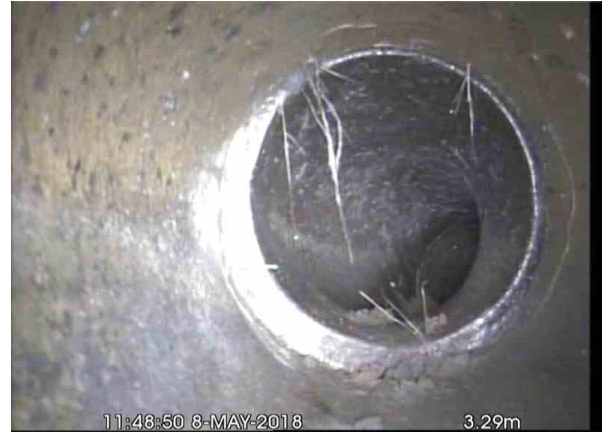
, 00:00:27, 3.17 m  
 Roots, fine at joint

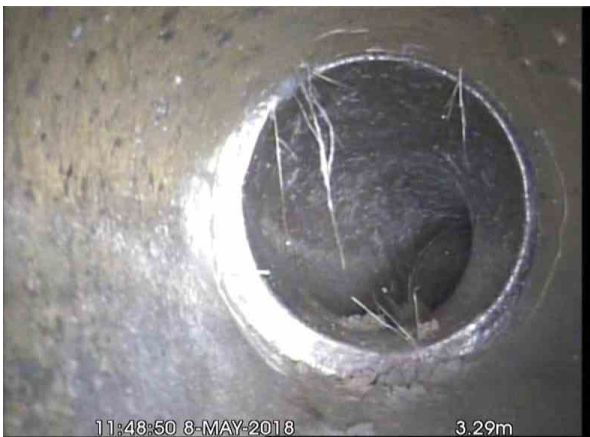
| Scale: 1:50 | Position [m] | Code | Observation | MPEG | Photo | Grade |
|---|---|---|---|---|---|---|
| | 3.17 | CCJ | Crack, circumferential at joint from 1 o'clock to 9 o'clock | 00:00:27 | | 2 |

, 00:00:27, 3.17 m  
 Crack, circumferential at joint from 1 o'clock to 9 o'clock

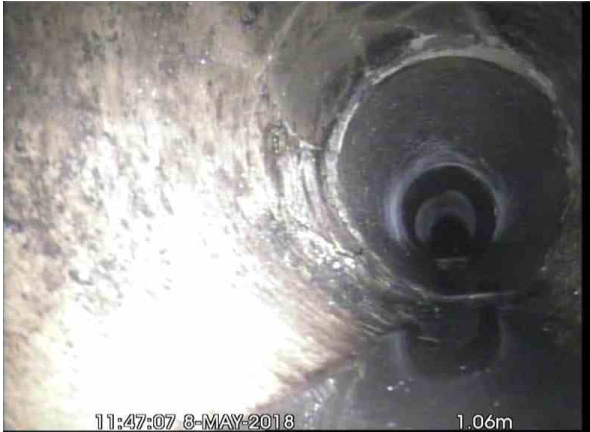
, 00:00:13, 1.06 m  
 Fracture, multiple at joint from 12 o'clock to 12 o'clock

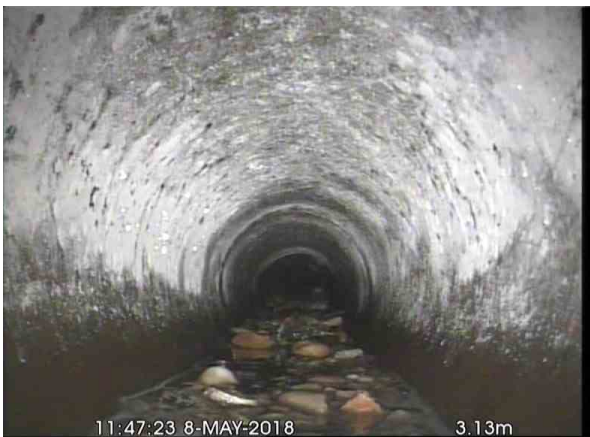
, 00:00:29, 3.13 m  
 Settled deposits, coarse at joint, 10% cross-sectional area loss

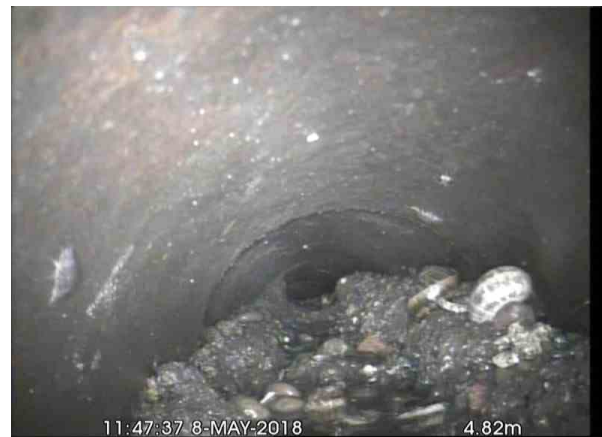
, 00:00:43, 4.82 m  
 Settled deposits, coarse at joint, 75% cross-sectional area loss

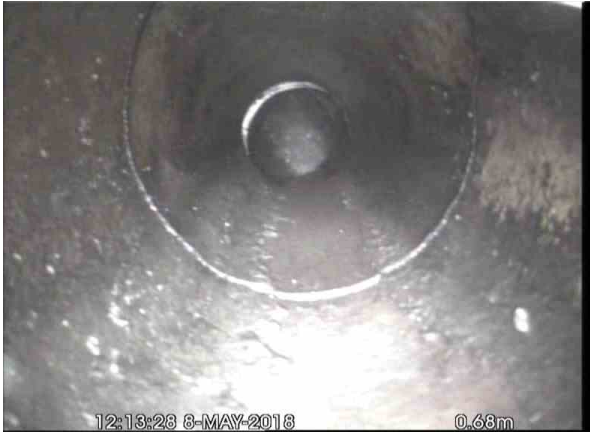
<table><tr><td>MH</td><td>Start node type, manhole, reference number: MH8 A</td><td>00:00:00</td><td></td><td></td></tr><tr><td>CCJ</td><td>Crack, circumferential at joint from 12 o'clock to 12 o'clock</td><td>00:00:08</td><td></td><td>2</td></tr></table>

, 00:00:08, 0.68 m  
 Crack, circumferential at joint from 12 o'clock to 12 o'clock

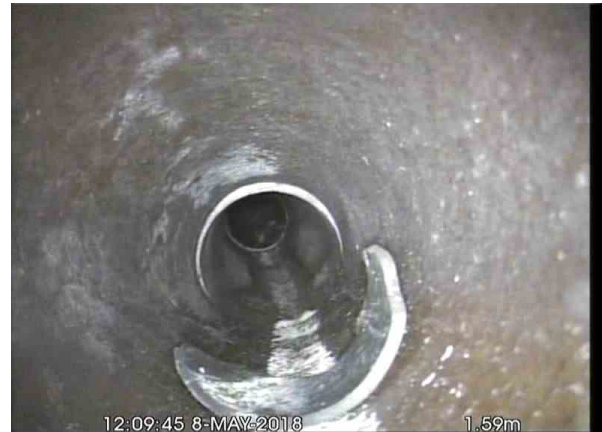
, 00:00:18, 1.59 m  
 Obstacles, pipe material in invert from 4 o'clock to 7 o'clock,  
 5% cross-sectional area loss

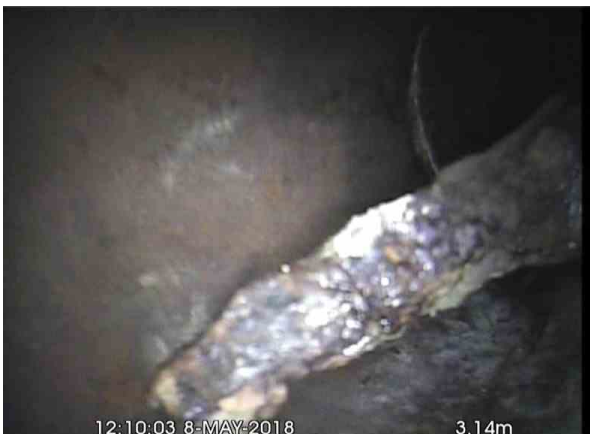
, 00:00:36, 3.14 m  
 Other obstacles from 3 o'clock to 7 o'clock, 30%  
 cross-sectional area loss

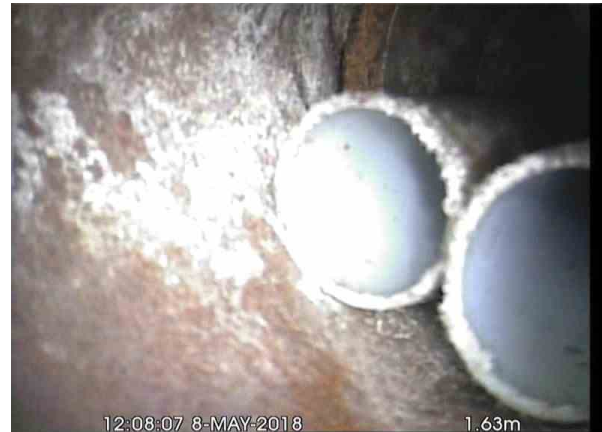
, 00:00:25, 1.63 m  
 Other obstacles in invert from 4 o'clock to 8 o'clock, 25% cross-sectional area loss

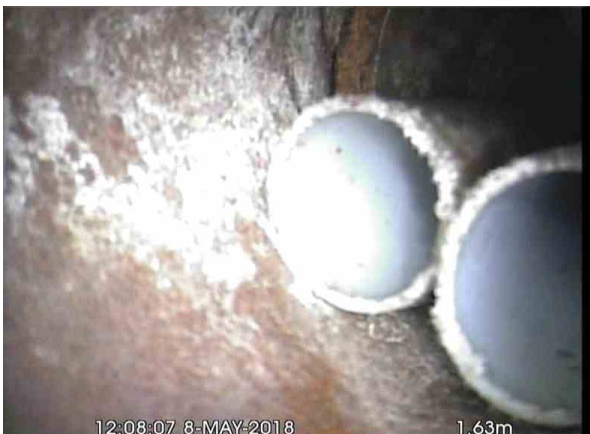
, 00:00:25, 1.63 m  
 Survey abandoned, Unable to pass obstacle

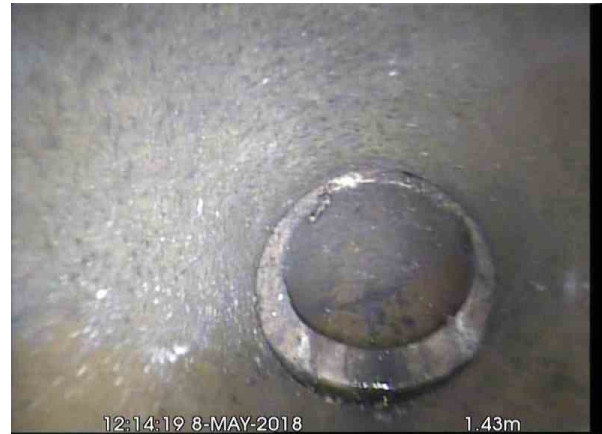
, 00:00:13, 1.43 m  
 Joint displaced, medium

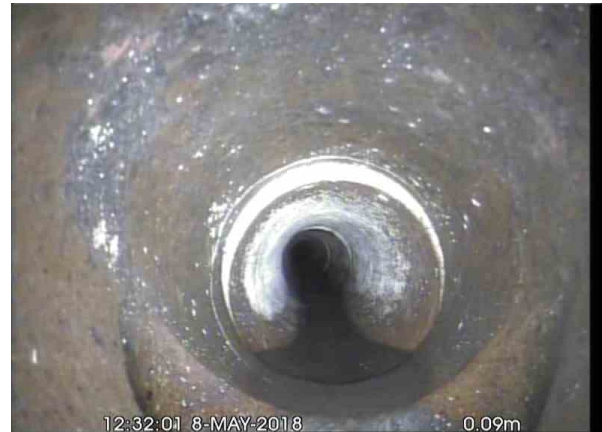
, 00:00:10, 0.09 m  
 Crack, circumferential at joint from 7 o'clock to 2 o'clock

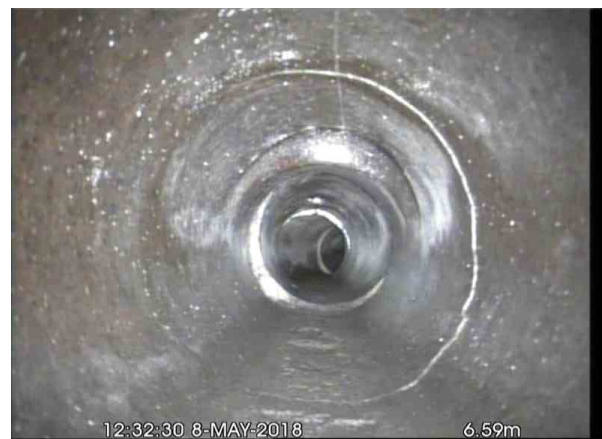
, 00:00:38, 6.59 m  
 Crack, circumferential from 12 o'clock to 12 o'clock

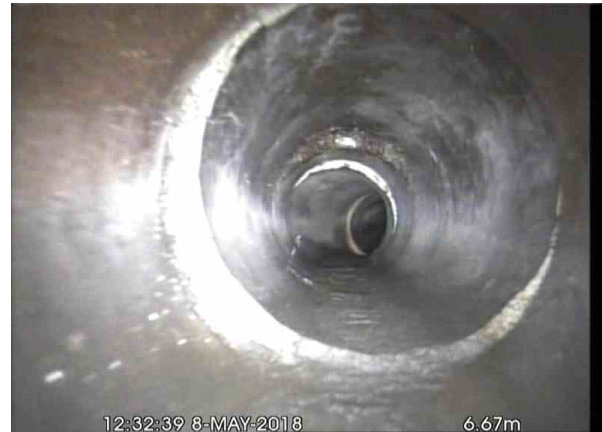
, 00:00:47, 6.67 m  
 Joint displaced, medium

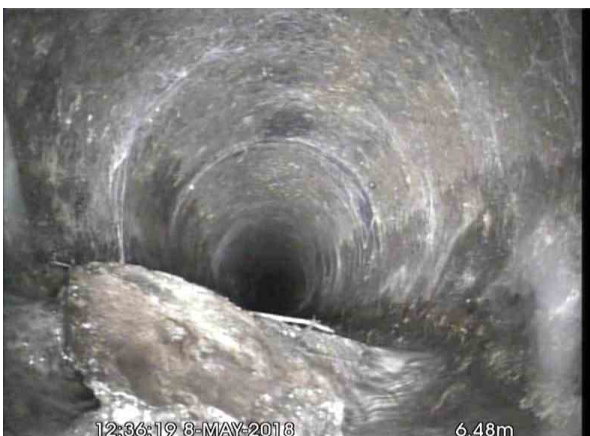
, 00:00:43, 6.48 m  
 Settled deposits, other, 10% cross-sectional area loss

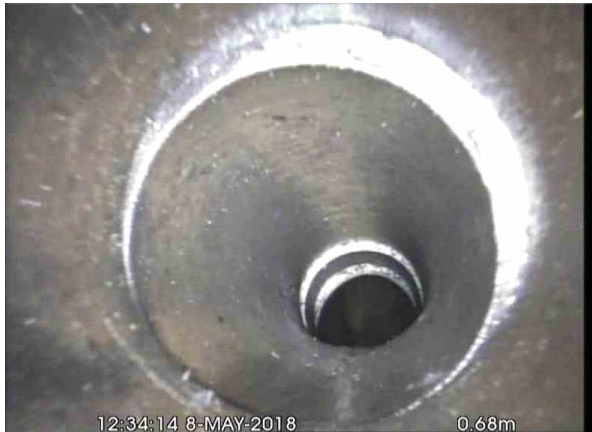
, 00:00:09, 0.68 m  
 Joint displaced, medium

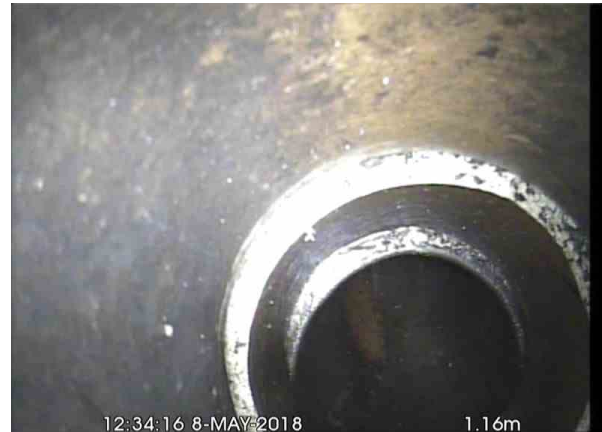
, 00:00:11, 1.16 m  
 Joint displaced, medium

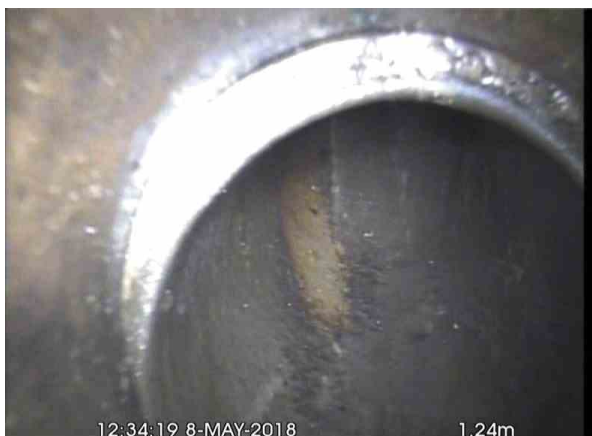
, 00:00:14, 1.24 m  
 Joint displaced, medium

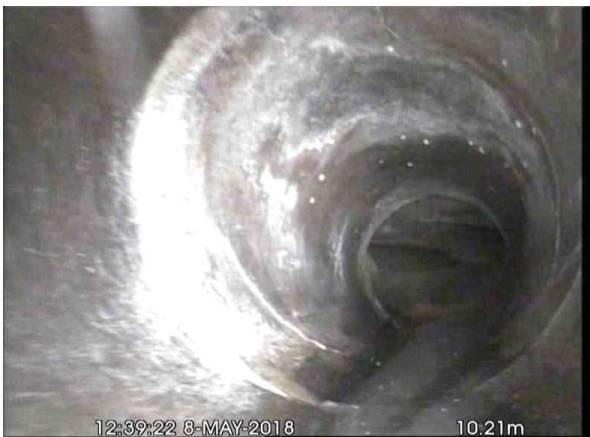
, 00:00:57, 10.21 m  
 Crack, circumferential at joint from 12 o'clock to 9 o'clock

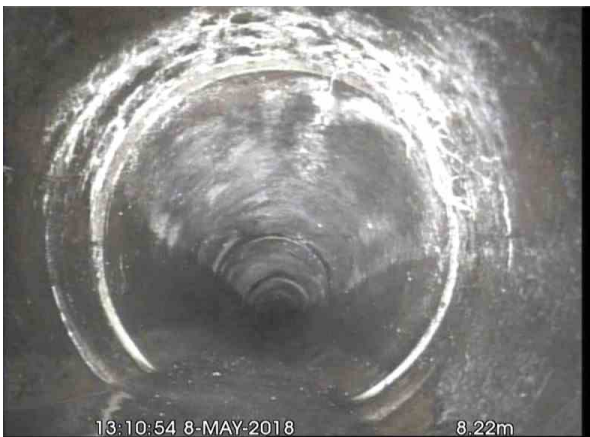
, 00:00:41, 8.22 m  
 Crack, circumferential at joint from 12 o'clock to 12 o'clock

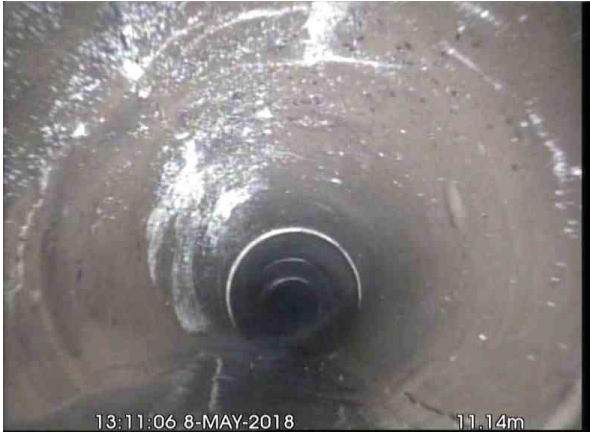
, 00:00:53, 11.14 m  
 Crack, longitudinal at joint at 5 o'clock

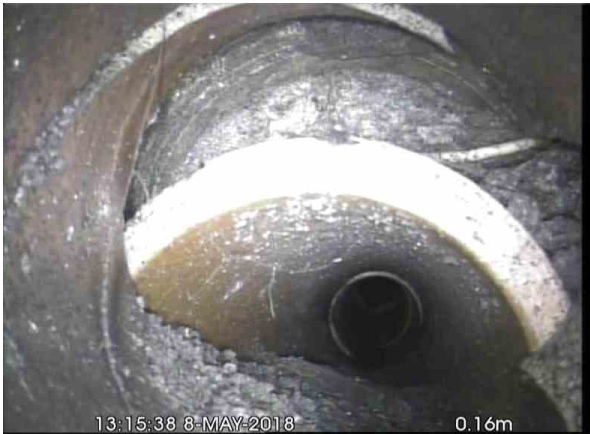
| Section | Inspection Direction | PLR | Client's Job Ref | Contractor's Job Ref |
|---|---|---|---|---|
| 39 | Upstream | | | DIUK-1021 |

, 00:00:20, 0.16 m  
 Collapsed drain or sewer

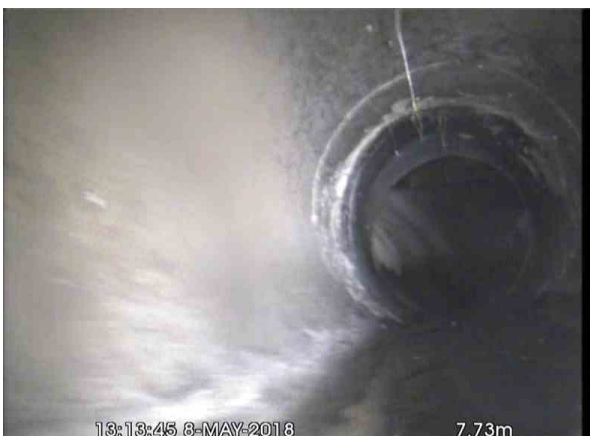
Crack, circumferential at joint from 7 o'clock to 4 o'clock

, 00:00:34, 7.73 m  
 Crack, circumferential at joint from 7 o'clock to 4 o'clock

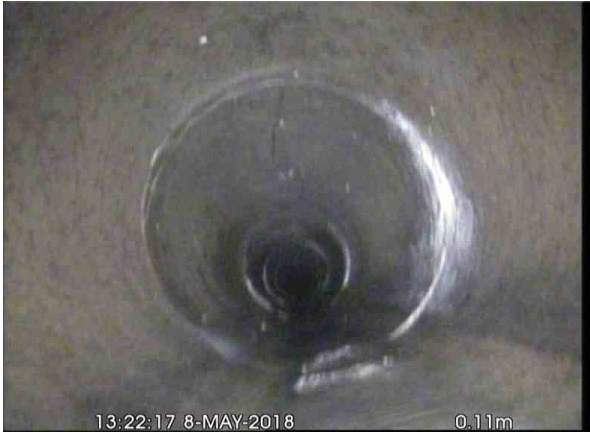
| Scale: 1:378 | Position [m] | Code | Observation | MPEG | Photo | Grade |
|---|---|---|---|---|---|---|
| | 0.11 | CCJ | Crack, circumferential at joint from 9 o'clock to 1 o'clock | 00:00:09 | | 2 |

, 00:00:09, 0.11 m  
 Crack, circumferential at joint from 9 o'clock to 1 o'clock

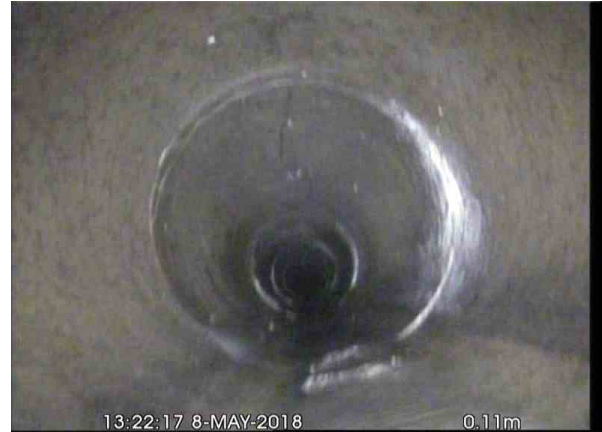
| Scale: 1:378 | Position [m] | Code | Observation | MPEG | Photo | Grade |
|---|---|---|---|---|---|---|
| | 0.11 | CLJ | Crack, longitudinal at joint at 12 o'clock | 00:00:09 | | 2 |

, 00:00:09, 0.11 m  
 Crack, longitudinal at joint at 12 o'clock

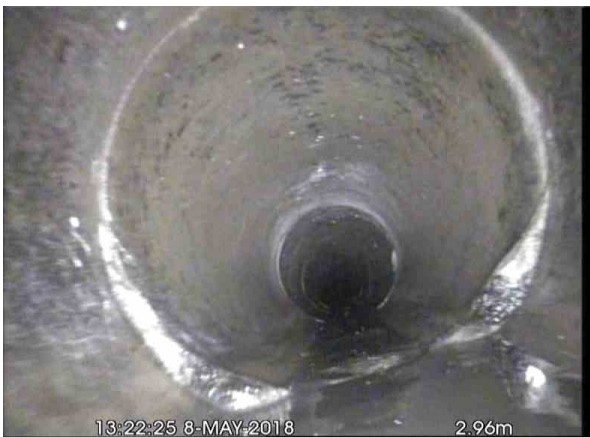
, 00:00:17, 2.96 m  
 Attached deposits, other at joint from 4 o'clock to 8 o'clock,  
 5% cross-sectional area loss

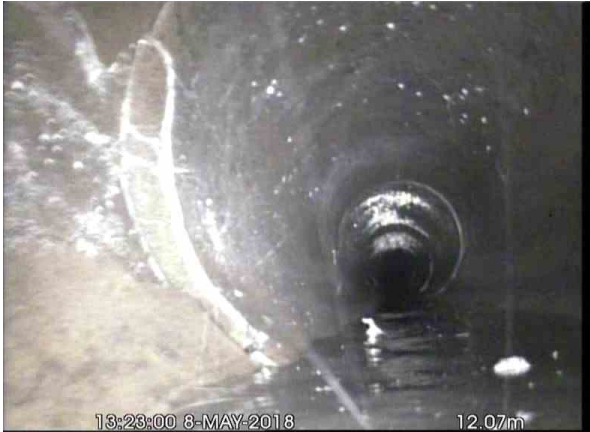
| Scale: 1:378 | Position [m] | Code | Observation | MPEG | Photo | Grade |
|---|---|---|---|---|---|---|
| | 12.07 | FCJ | Fracture, circumferential at joint from 7 o'clock to 10 o'clock | 00:00:53 | | 3 |

, 00:00:53, 12.07 m  
 Fracture, circumferential at joint from 7 o'clock to 10 o'clock

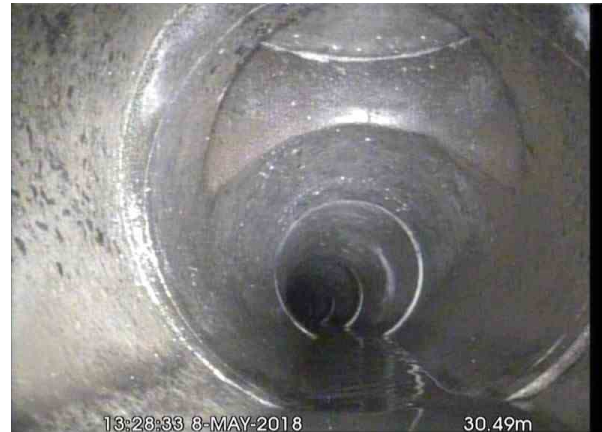
| Scale: 1:378 | Position [m] | Code | Observation | MPEG | Photo | Grade |
|---|---|---|---|---|---|---|
| | 30.49 | CCJ | Crack, circumferential at joint from 12 o'clock to 12 o'clock | 00:06:25 | | 2 |

, 00:06:25, 30.49 m  
 Crack, circumferential at joint from 12 o'clock to 12 o'clock

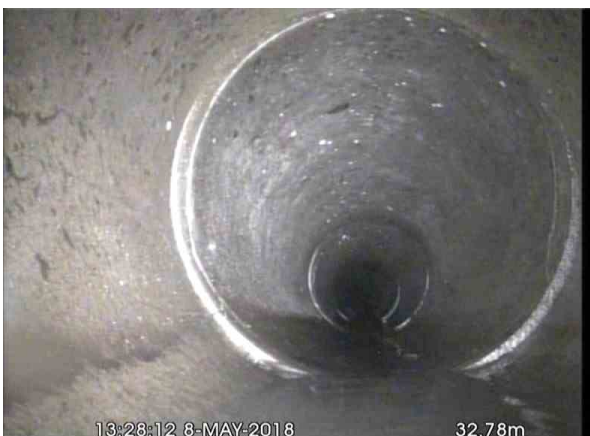
| Scale: 1:378 | Position [m] | Code | Observation | MPEG | Photo | Grade |
|---|---|---|---|---|---|---|
| | 32.78 | CCJ | Crack, circumferential at joint from 7 o'clock to 4 o'clock | 00:06:04 | | 2 |

, 00:06:04, 32.78 m  
 Crack, circumferential at joint from 7 o'clock to 4 o'clock

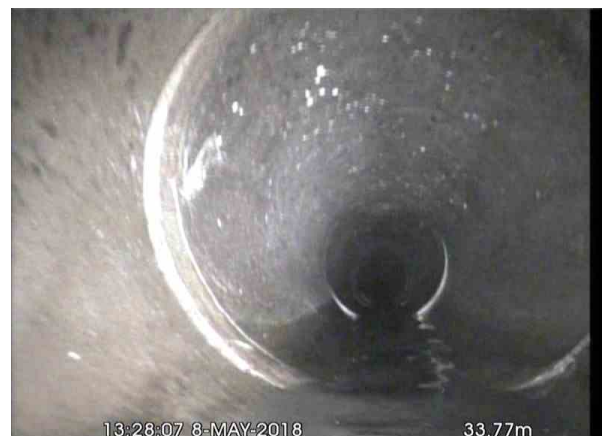
| Scale: 1:378 | Position [m] | Code | Observation | MPEG | Photo | Grade |
|---|---|---|---|---|---|---|
| | 33.77 | CCJ | Crack, circumferential at joint from 7 o'clock to 10 o'clock | 00:05:59 | | 2 |

, 00:05:59, 33.77 m  
 Crack, circumferential at joint from 7 o'clock to 10 o'clock

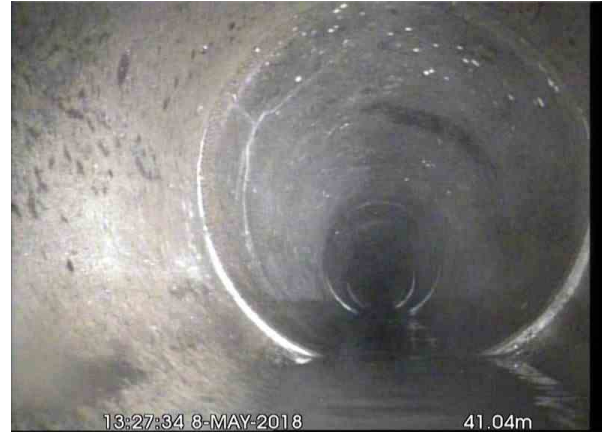
| Scale: 1:378 | Position [m] | Code | Observation | MPEG | Photo | Grade |
|---|---|---|---|---|---|---|
| | 41.04 | CCJ | Crack, circumferential at joint from 8 o'clock to 11 o'clock | 00:05:26 | | 2 |

, 00:05:26, 41.04 m  
 Crack, circumferential at joint from 8 o'clock to 11 o'clock

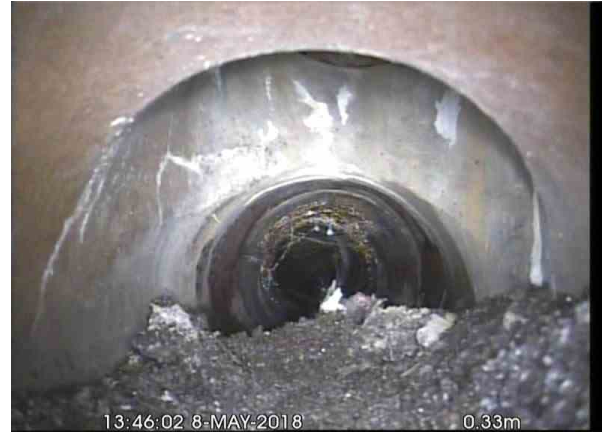
, 00:00:11, 0.33 m  
 Settled deposits, fine, 25% cross-sectional area loss

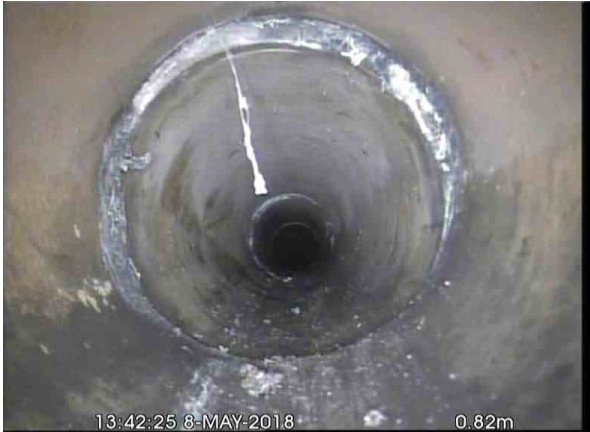
, 00:00:09, 0.82 m  
 Joint displaced, medium

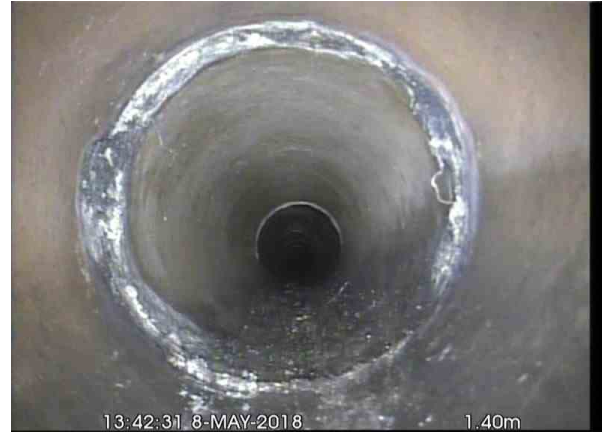
, 00:00:14, 1.40 m  
 Attached deposits, other at joint from 12 o'clock to 12 o'clock,  
 5% cross-sectional area loss

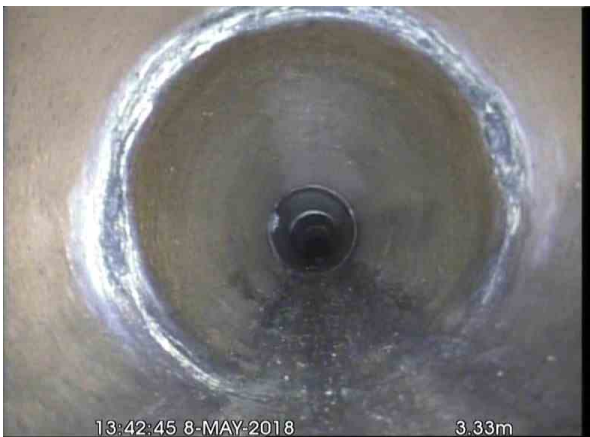
, 00:00:28, 3.33 m  
 Attached deposits, other at joint from 12 o'clock to 12 o'clock,  
 5% cross-sectional area loss

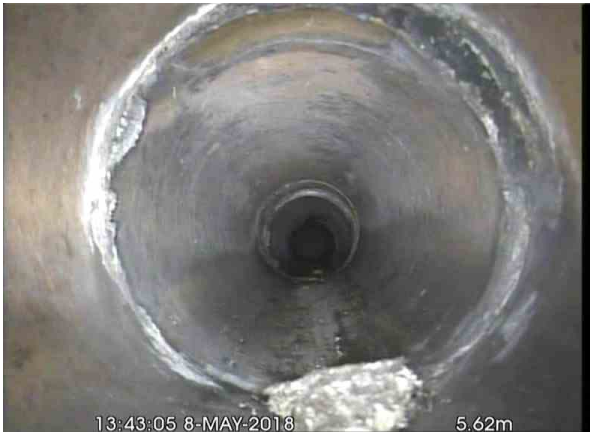
, 00:00:49, 5.62 m  
 Attached deposits, other at joint from 12 o'clock to 12 o'clock,  
 5% cross-sectional area loss

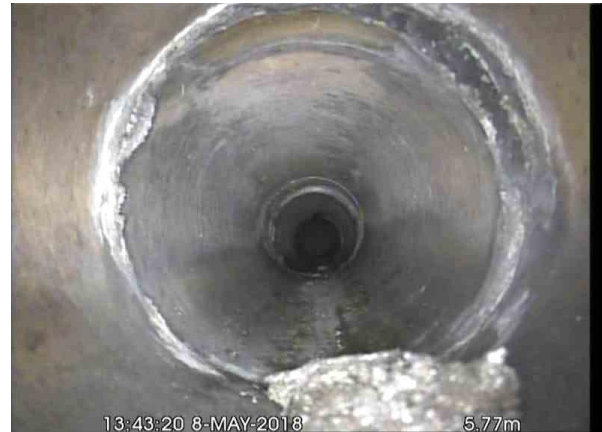
| Scale: 1:71 | Position [m] | Code | Observation | MPEG | Photo | Grade |
|---|---|---|---|---|---|---|
| 5.77 | CCJ | Crack, circumferential at joint from 11 o'clock to 1 o'clock | 00:01:04 | | | 2 |

, 00:01:04, 5.77 m  
 Crack, circumferential at joint from 11 o'clock to 1 o'clock

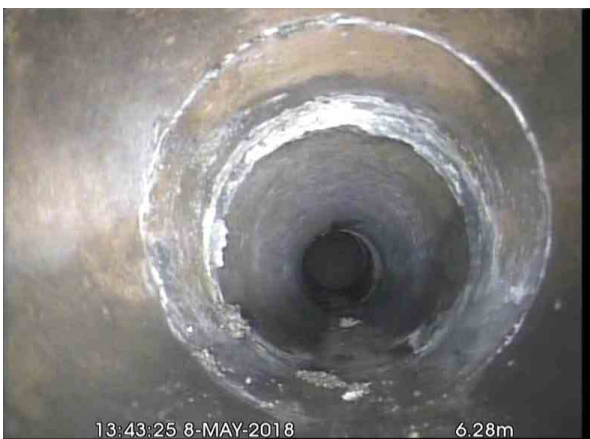
| Scale: 1:71 | Position [m] | Code | Observation | MPEG | Photo | Grade |
|---|---|---|---|---|---|---|
| 6.28 | CCJ | Crack, circumferential at joint from 12 o'clock to 12 o'clock | 00:01:09 | | | 2 |

, 00:01:09, 6.28 m  
 Crack, circumferential at joint from 12 o'clock to 12 o'clock

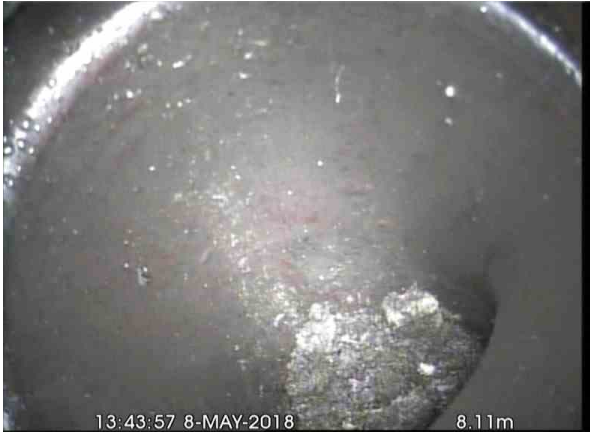
, 00:01:41, 8.11 m  
 Settled deposits, fine, 30% cross-sectional area loss

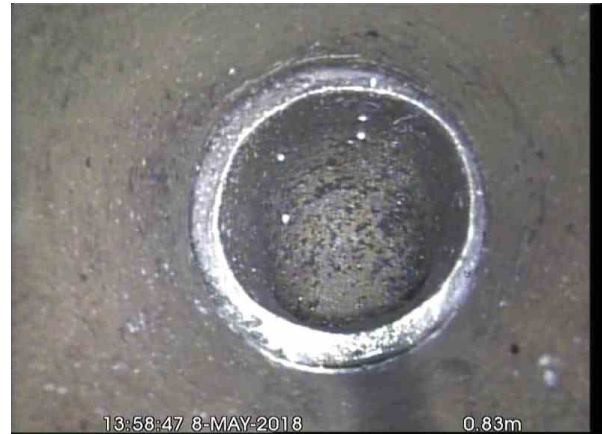
, 00:00:13, 0.83 m  
 Joint displaced, medium

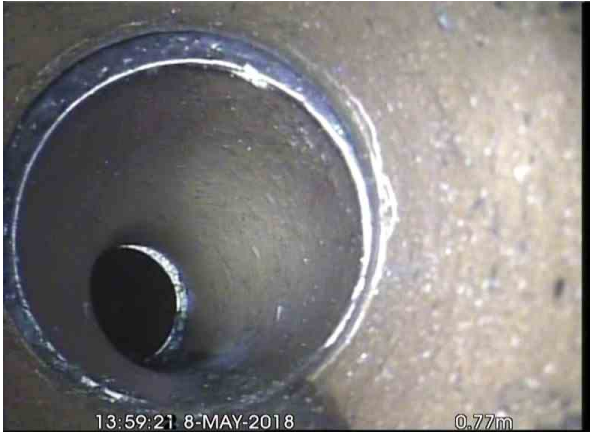
, 00:00:11, 0.77 m  
 Joint displaced, medium

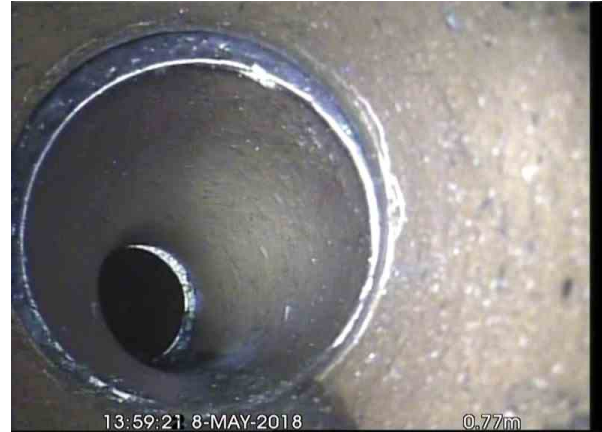
| Scale: 1:50 | Position [m] | Code | Observation | MPEG | Photo | Grade |
|---|---|---|---|---|---|---|
| | 0.77 | CCJ | Crack, circumferential at joint from 1 o'clock to 6 o'clock | 00:00:11 | | 2 |

, 00:00:11, 0.77 m  
 Crack, circumferential at joint from 1 o'clock to 6 o'clock

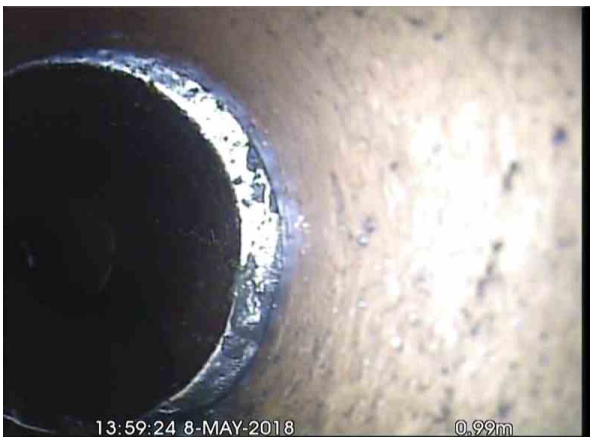
, 00:00:13, 0.99 m  
 Joint displaced, medium

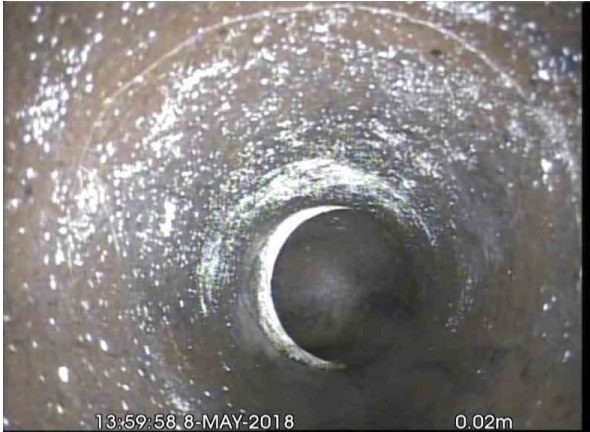
, 00:00:02, 0.02 m  
 Crack, circumferential at joint from 9 o'clock to 3 o'clock

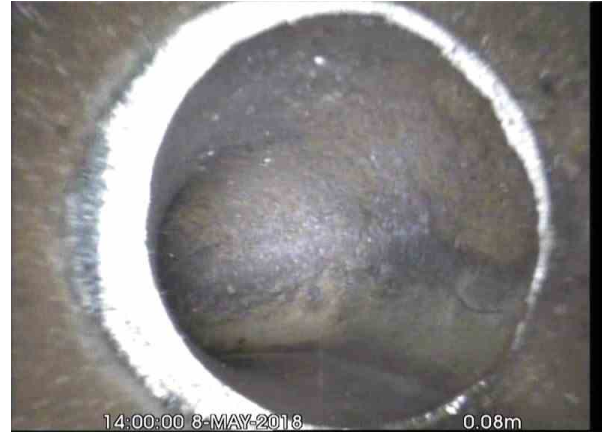
, 00:00:04, 0.08 m  
 Joint displaced, medium

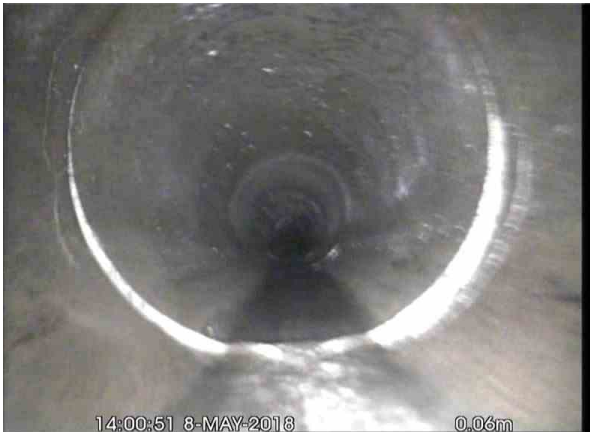
| Scale: 1:115 | Position [m] | Code | Observation | MPEG | Photo | Grade |
|---|---|---|---|---|---|---|
| | 0.06 | CCJ | Crack, circumferential at joint from 1 o'clock to 5 o'clock | 00:00:10 | | 2 |

, 00:00:10, 0.06 m  
 Crack, circumferential at joint from 1 o'clock to 5 o'clock

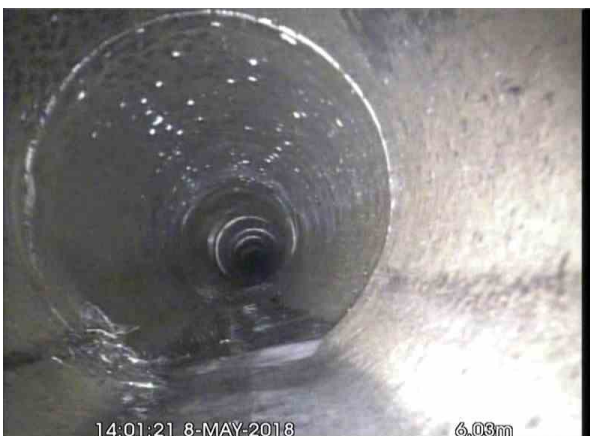
, 00:00:40, 6.03 m  
 Roots, fine at joint

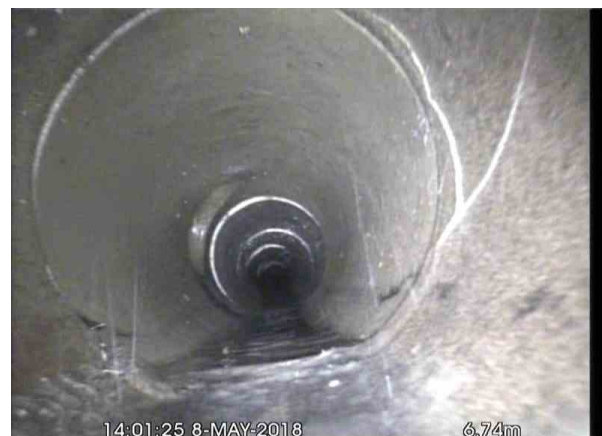
| Scale: 1:115 | Position [m] | Code | Observation | MPEG | Photo | Grade |
|---|---|---|---|---|---|---|
| | 6.74 | CCJ | Crack, circumferential at joint from 1 o'clock to 4 o'clock | 00:00:44 | | 2 |

, 00:00:44, 6.74 m  
 Crack, circumferential at joint from 1 o'clock to 4 o'clock

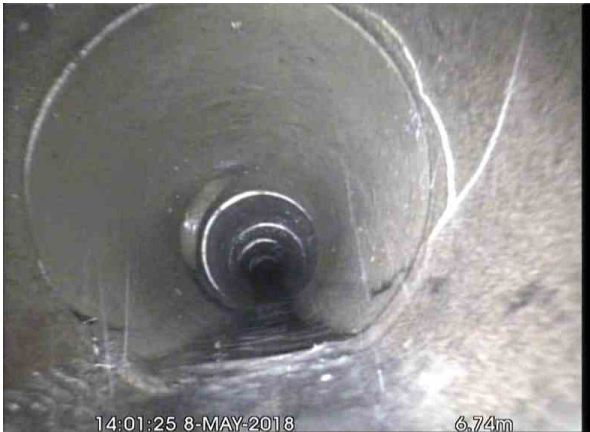
, 00:00:44, 6.74 m  
 Roots, tap at joint
