**Project Name:** DIUK-1021\_02 St Marys Gate, Derby CCTV Report  
**Job Status:** Complete  
**Project Date:** 10/05/2018  
**Project Standard:** MSCC4 Sewers & Drainage GB (SRM4 Scoring)

# Drain Inspect UK

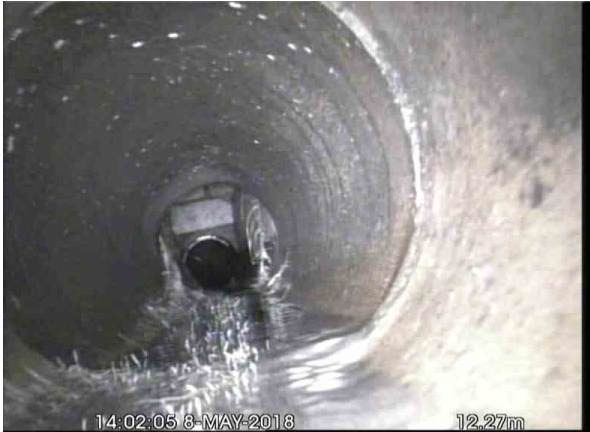
, 00:01:24, 12.27 m  
 Roots, mass, 5% cross-sectional area loss

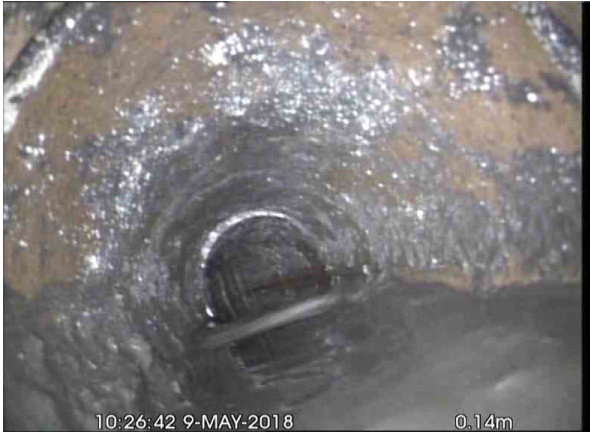
, 00:00:09, 0.14 m  
 Settled deposits, fine, 10% cross-sectional area loss, start

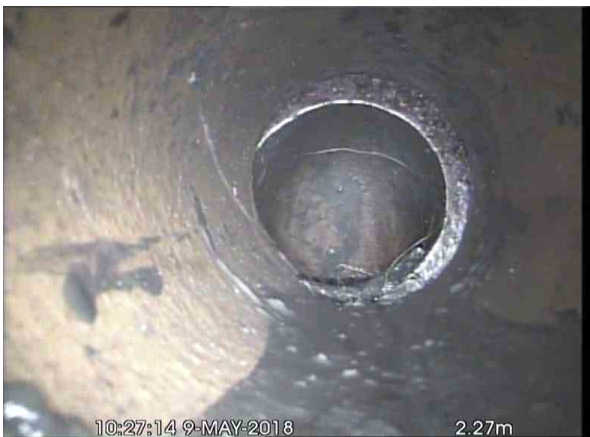
, 00:00:40, 2.39 m  
 Joint displaced, medium

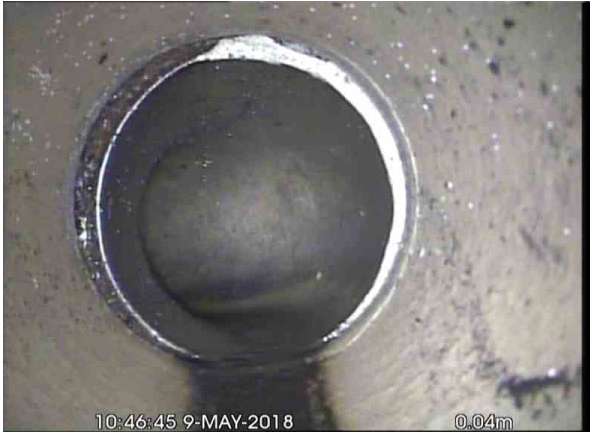
| Scale: 1:50 | Position [m] | Code | Observation | MPEG | Photo | Grade |
|---|---|---|---|---|---|---|
| | 0.04 | CCJ | Crack, circumferential at joint from 12 o'clock to 6 o'clock | 00:00:05 | | 2 |

, 00:00:05, 0.04 m  
 Crack, circumferential at joint from 12 o'clock to 6 o'clock

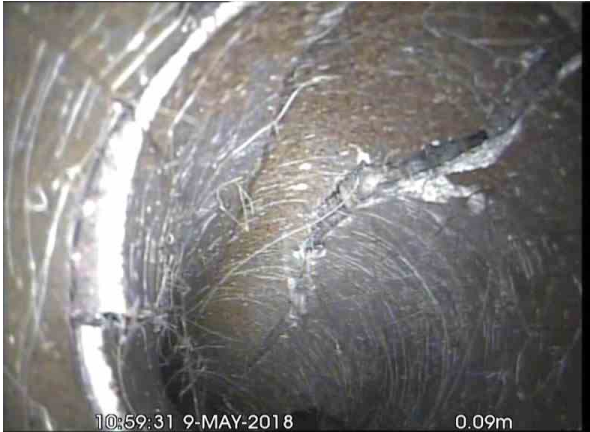
| Scale: 1:50 | Position [m] | Code | Observation | MPEG | Photo | Grade |
|---|---|---|---|---|---|---|
| | 0.09 | FMJ | Fracture, multiple at joint from 12 o'clock to 12 o'clock | 00:00:06 | | 4 |

, 00:00:06, 0.09 m  
 Fracture, multiple at joint from 12 o'clock to 12 o'clock

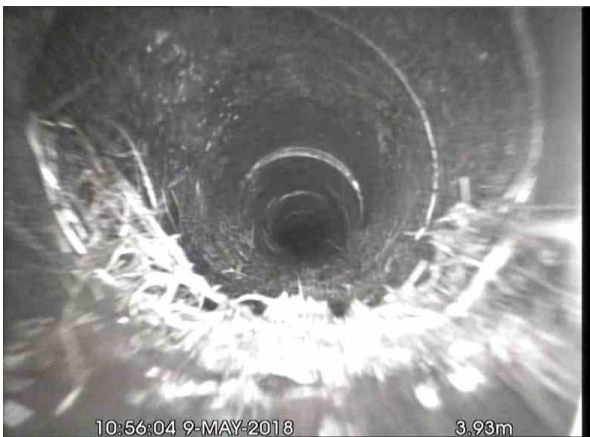
| Scale: 1:134 | Position [m] | Code | Observation | MPEG | Photo | Grade |
|---|---|---|---|---|---|---|
| 3.93 | CCJ | | Crack, circumferential at joint from 11 o'clock to 6 o'clock | 00:00:27 | | 2 |

, 00:00:27, 3.93 m  
 Crack, circumferential at joint from 11 o'clock to 6 o'clock

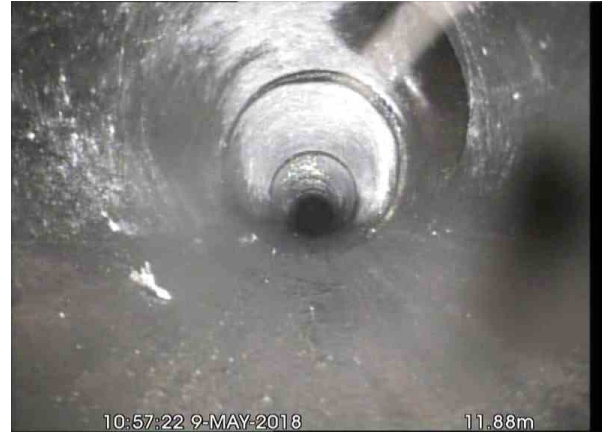
, 00:01:45, 11.88 m  
 Junction at 2 o'clock, diameter: 100mm

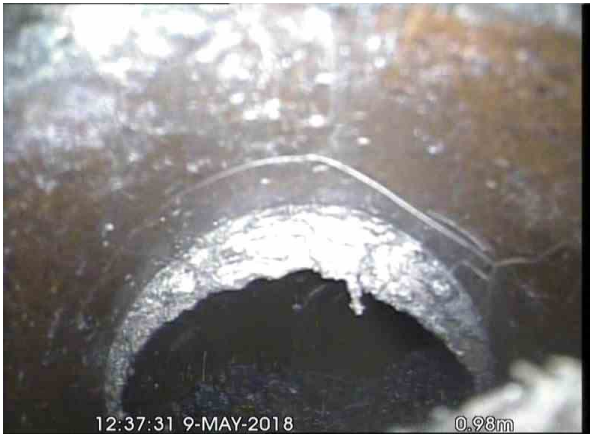
, 00:00:15, 0.98 m  
 Joint displaced, medium

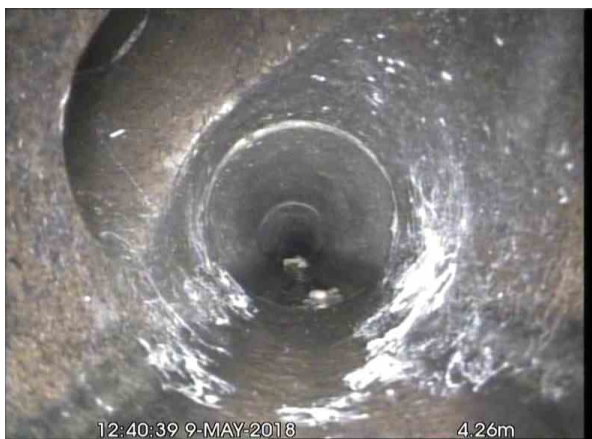
, 00:00:26, 4.26 m  
 Junction at 10 o'clock, diameter: 100mm

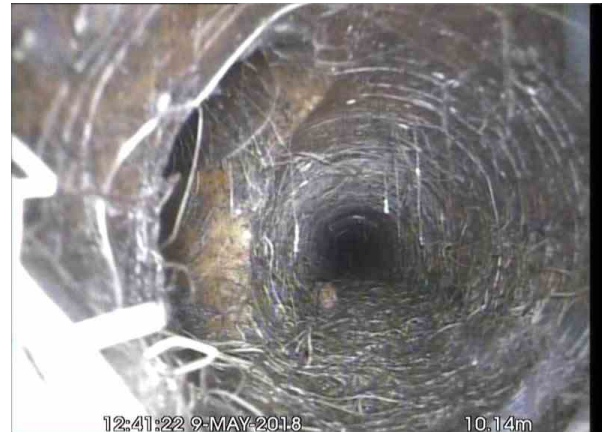
, 00:01:09, 10.14 m  
 Junction at 10 o'clock, diameter: 100mm

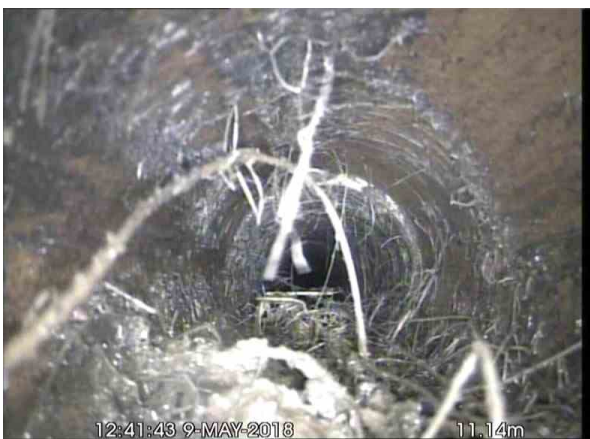
, 00:01:30, 11.14 m  
 Survey abandoned, Unable to pass mass root ingress

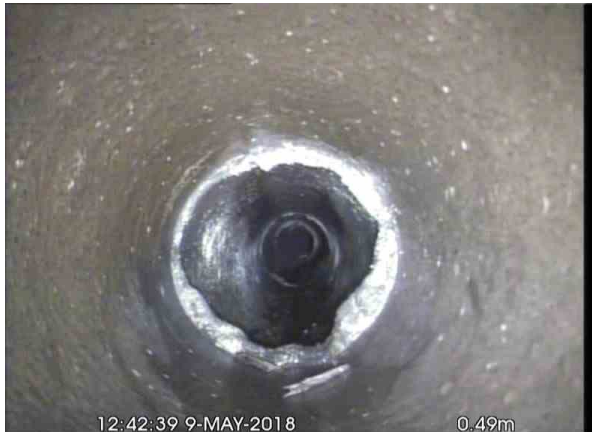
, 00:00:08, 0.49 m  
 Attached deposits, other at joint from 12 o'clock to 12 o'clock,  
 5% cross-sectional area loss

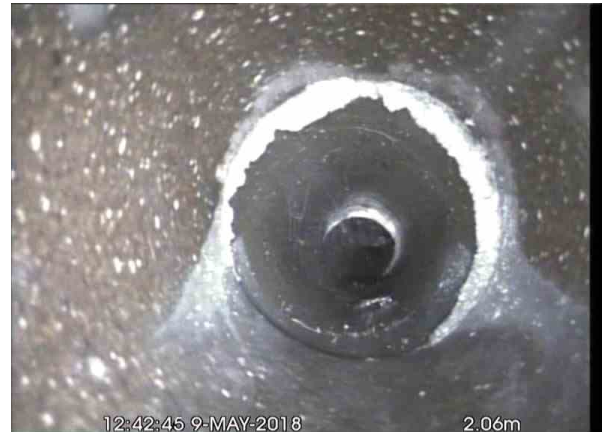
, 00:00:15, 2.06 m  
 Attached deposits, other at joint from 8 o'clock to 5 o'clock,  
 5% cross-sectional area loss

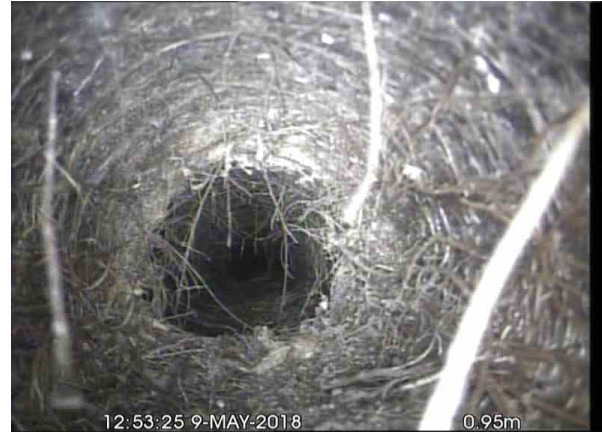
, 00:00:17, 0.95 m  
 Survey abandoned, Unable to pass mass root ingress

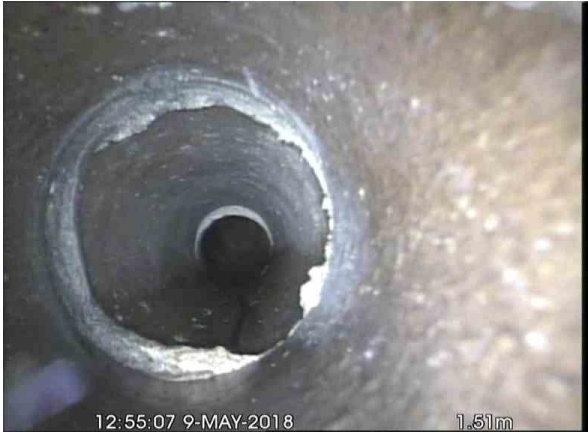
, 00:00:18, 1.51 m  
 Attached deposits, other at joint from 5 o'clock to 3 o'clock,  
 5% cross-sectional area loss

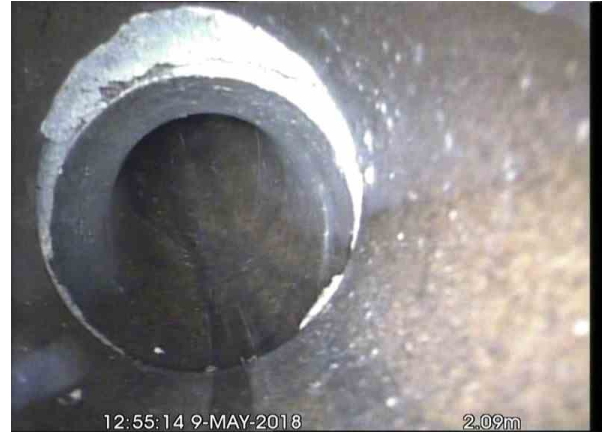
, 00:00:25, 2.09 m  
 Joint displaced, medium

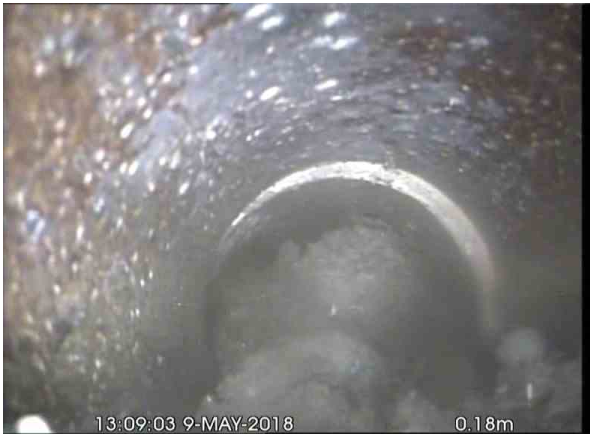
, 00:00:14, 0.18 m  
 Settled deposits, fine, 90% cross-sectional area loss

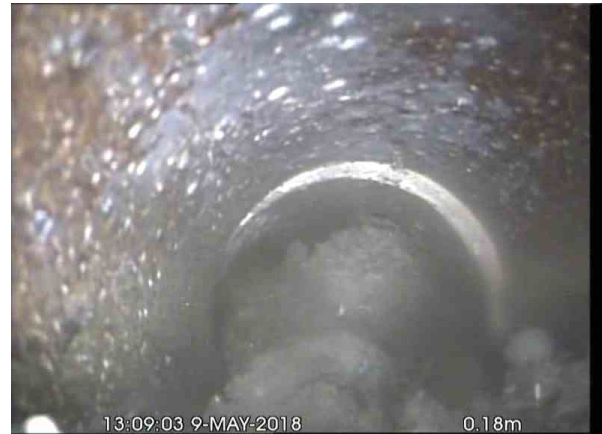
, 00:00:14, 0.18 m  
 Survey abandoned, Unable to pass debris

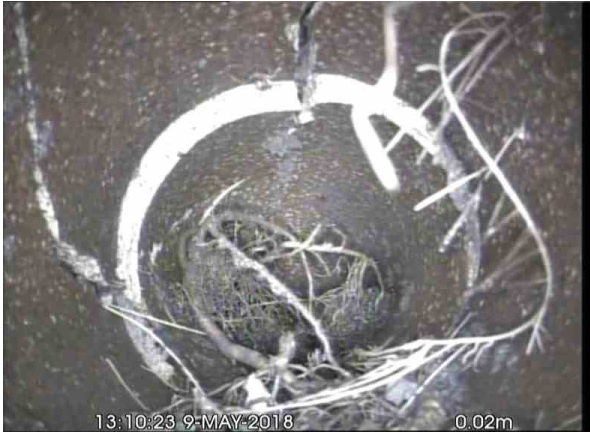
| Scale: 1:50 | Position [m] | Code | Observation | MPEG | Photo | Grade |
|---|---|---|---|---|---|---|
| | 0.02 | FMJ | Fracture, multiple at joint from 7 o'clock to 1 o'clock | 00:00:17 | | 4 |

, 00:00:17, 0.02 m  
 Fracture, multiple at joint from 7 o'clock to 1 o'clock

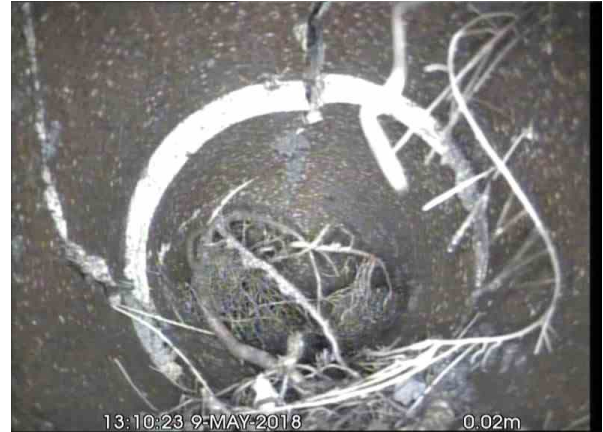
, 00:00:17, 0.02 m  
 Roots, mass at joint, 20% cross-sectional area loss

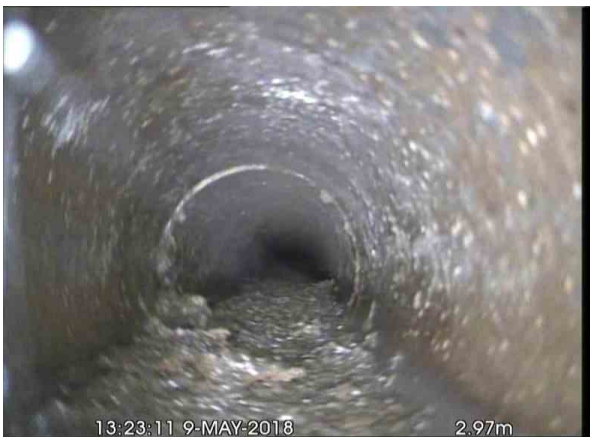
, 00:00:37, 2.97 m  
 Settled deposits, fine, 15% cross-sectional area loss, start

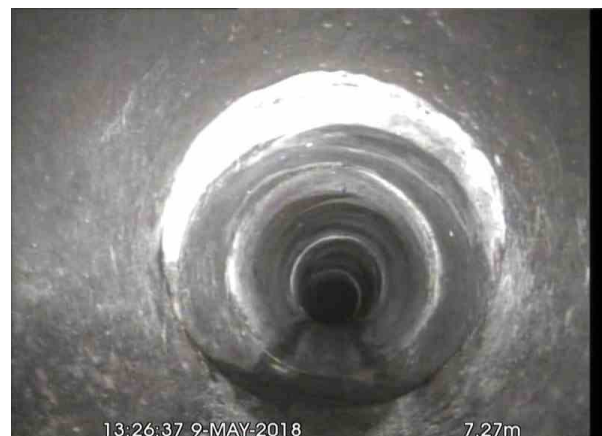
, 00:00:52, 7.27 m  
 Joint displaced, medium

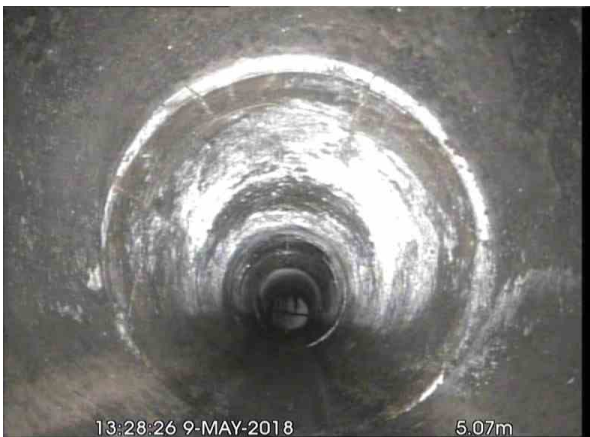
, 00:00:49, 5.07 m  
 Cracks, multiple at joint from 9 o'clock to 3 o'clock

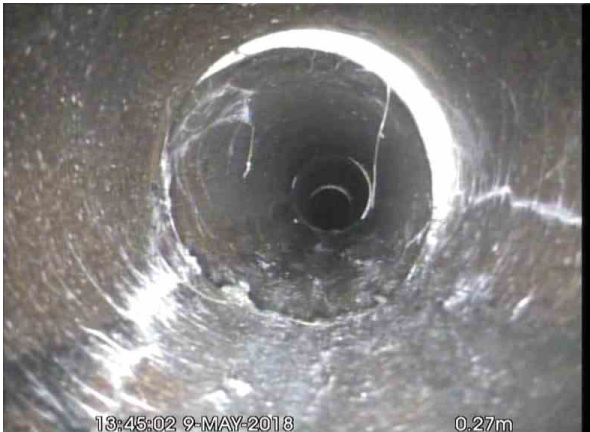
, 00:00:05, 0.27 m  
 Joint displaced, medium

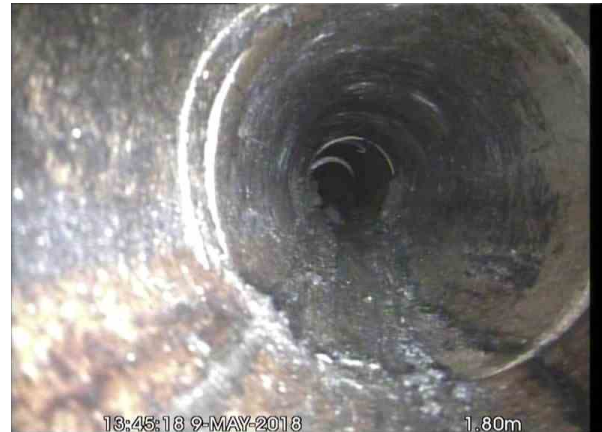
, 00:00:22, 2.00 m  
 Crack, circumferential at joint from 8 o'clock to 12 o'clock

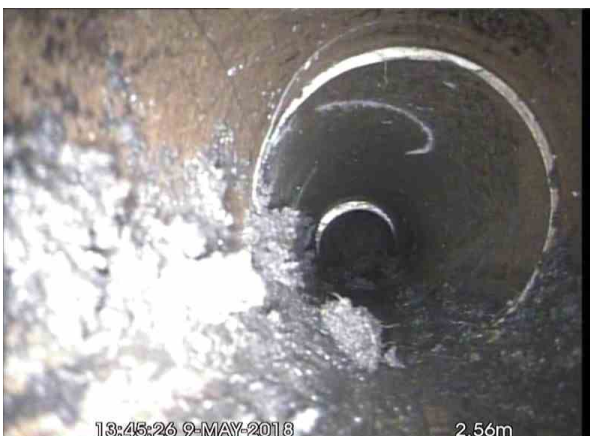
, 00:00:30, 2.56 m  
 Crack, circumferential at joint from 9 o'clock to 2 o'clock

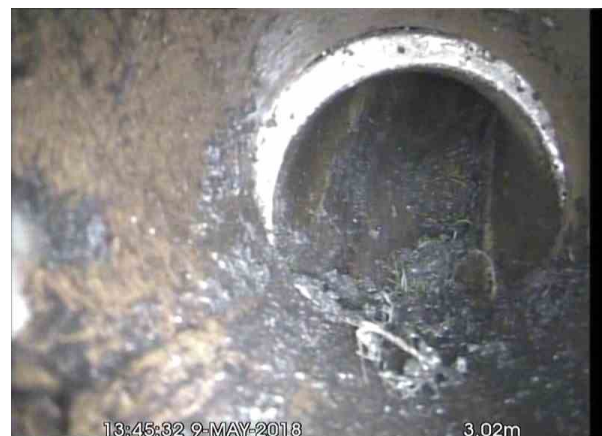
, 00:00:36, 3.02 m  
 Joint displaced, medium

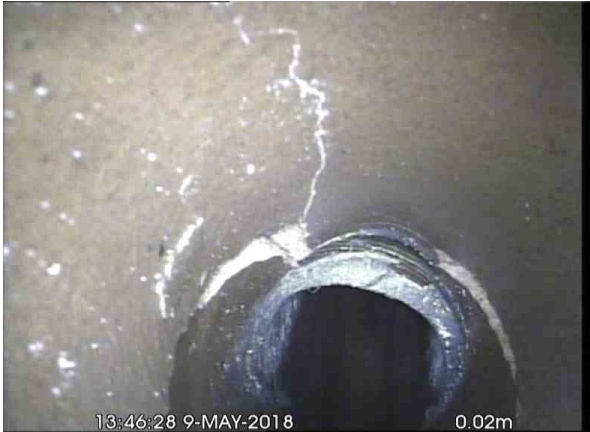
, 00:00:04, 0.02 m  
 Broken pipe at joint from 9 o'clock to 4 o'clock ,

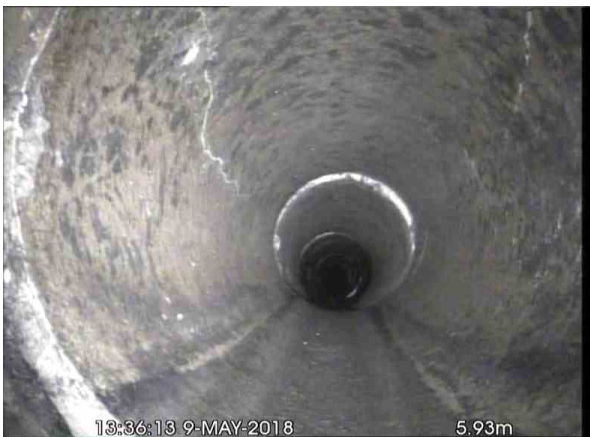
| Scale: 1:176 | Position [m] | Code | Observation | MPEG | Photo | Grade |
|---|---|---|---|---|---|---|
| | 5.93 | CL | Crack, longitudinal at 11 o'clock | 00:01:00 | | 2 |

, 00:01:00, 5.93 m  
 Crack, longitudinal at 11 o'clock

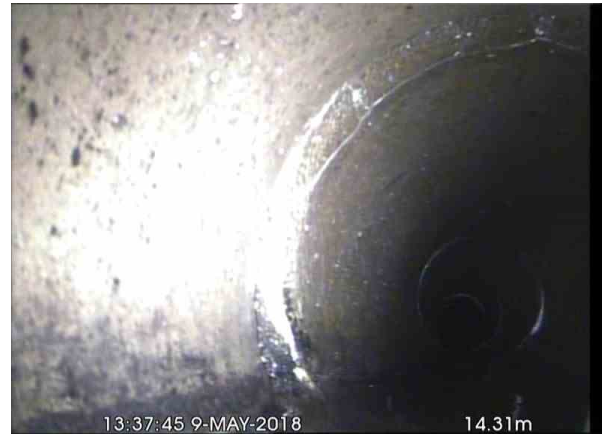
| Scale: 1:176 | Position [m] | Code | Observation | MPEG | Photo | Grade |
|---|---|---|---|---|---|---|
| | 14.31 | CCJ | Crack, circumferential at joint from 7 o'clock to 1 o'clock | 00:02:32 | | 2 |

, 00:02:32, 14.31 m  
 Crack, circumferential at joint from 7 o'clock to 1 o'clock

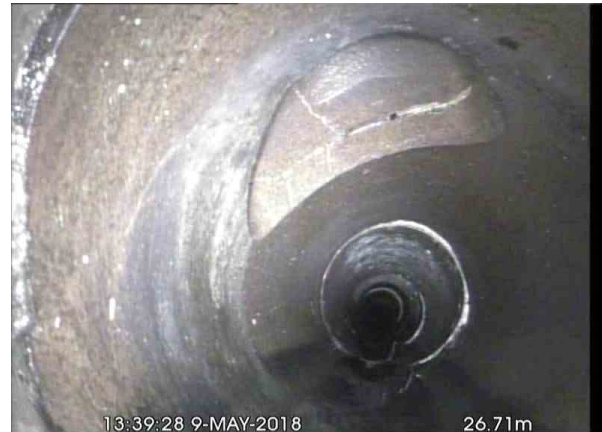
| Scale: 1:176 | Position [m] | Code | Observation | MPEG | Photo | Grade | | | |
|---|---|---|---|---|---|---|---|---|---|
| | 26.71 | JXD | Defective junction, damaged at 10 o'clock, diameter: 100mm | 00:04:15 | | | | | |

, 00:04:15, 26.71 m  
 Defective junction, damaged at 10 o'clock, diameter: 100mm

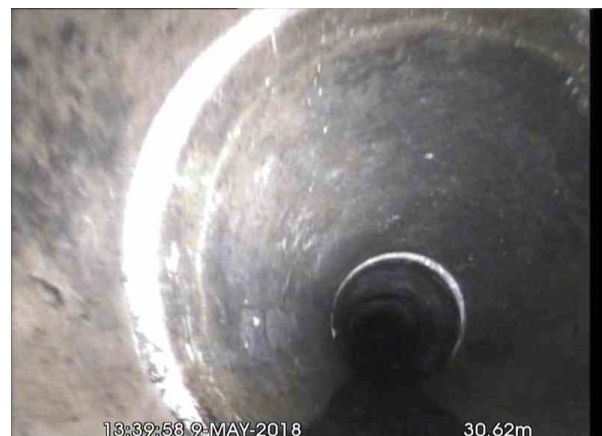
| Scale: 1:176 | Position [m] | Code | Observation | MPEG | Photo | Grade | | | |
|---|---|---|---|---|---|---|---|---|---|
| | 30.54 | CCJ | Crack, circumferential at joint from 7 o'clock to 2 o'clock | 00:04:45 | | 2 | | | |

, 00:04:45, 30.54 m  
 Crack, circumferential at joint from 7 o'clock to 2 o'clock

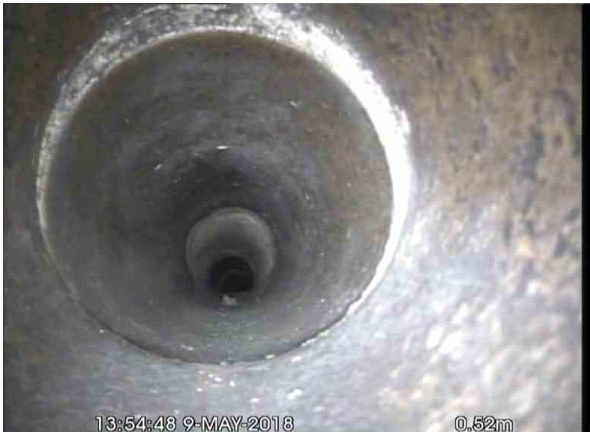
, 00:00:08, 0.52 m  
 Joint displaced, medium

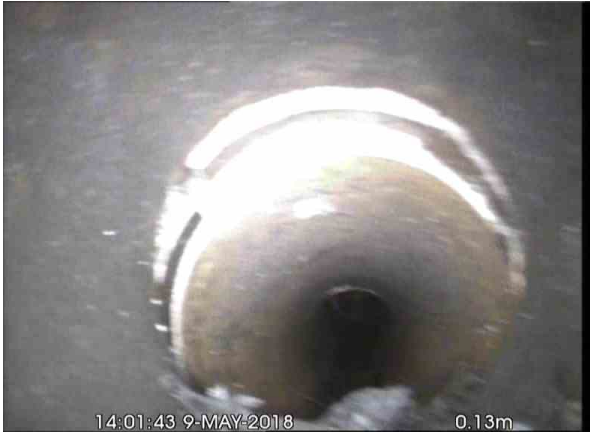
| Scale: 1:50 | Position [m] | Code | Observation | MPEG | Photo | Grade |
|---|---|---|---|---|---|---|
| | 0.13 | FMJ | Fracture, multiple at joint from 10 o'clock to 2 o'clock | 00:00:08 | | 4 |

, 00:00:08, 0.13 m  
 Fracture, multiple at joint from 10 o'clock to 2 o'clock

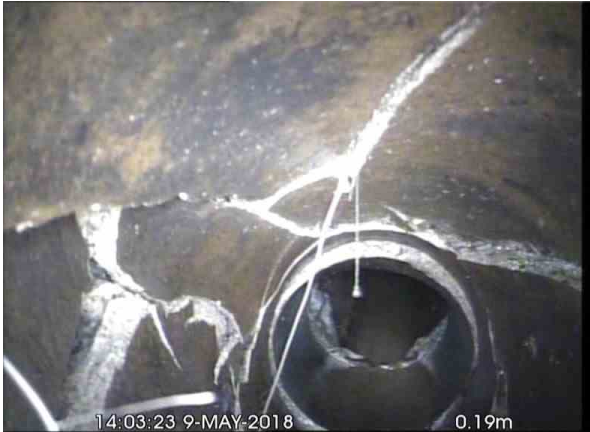
, 00:00:05, 0.19 m  
 Broken pipe from 12 o'clock to 12 o'clock

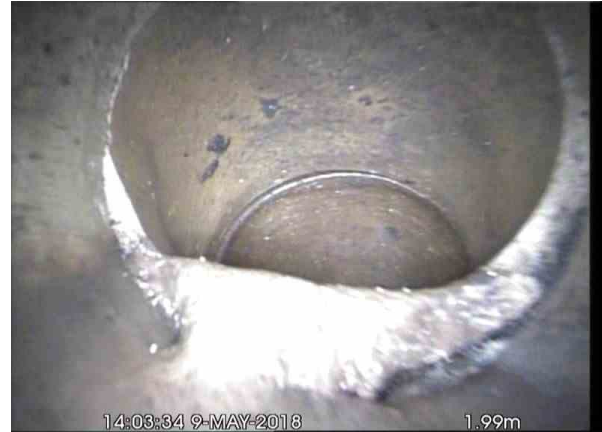
, 00:00:17, 1.99 m  
 Attached deposits, other at joint from 5 o'clock to 7 o'clock,  
 5% cross-sectional area loss

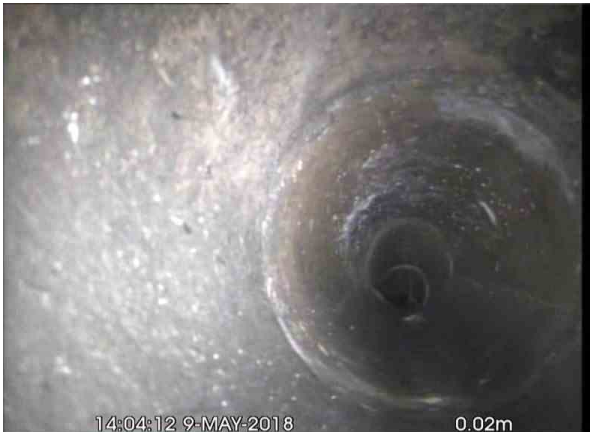
, 00:00:03, 0.02 m  
 Crack, longitudinal at joint at 4 o'clock

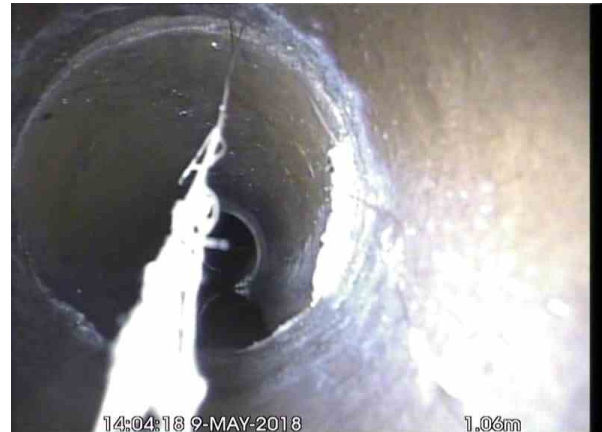
, 00:00:09, 1.06 m  
 Roots, tap at joint

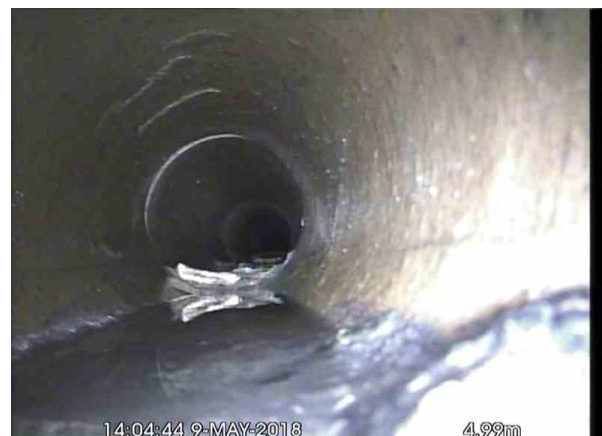
, 00:00:36, 4.99 m  
 Settled deposits, other, 5% cross-sectional area loss, start

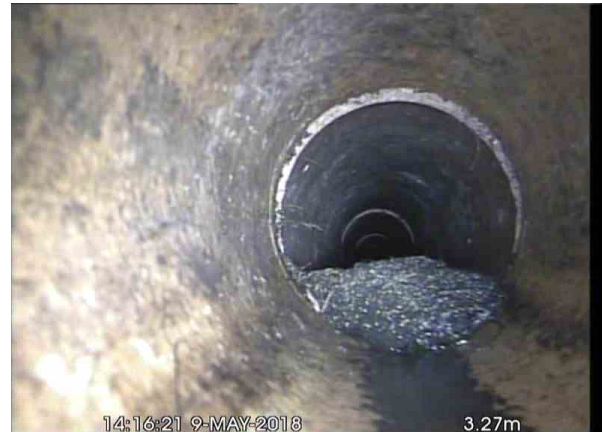
, 00:00:38, 3.27 m  
 Roots, mass at joint, 10% cross-sectional area loss

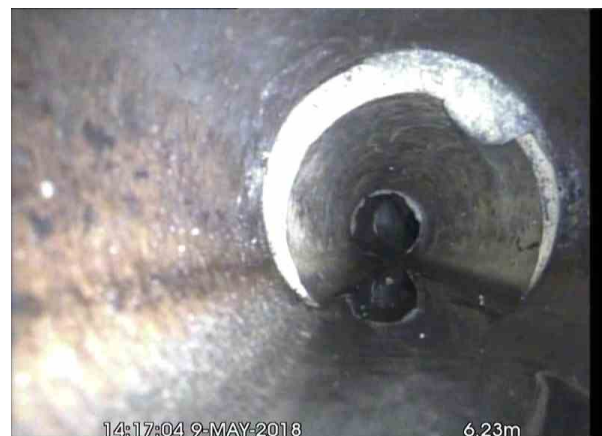
, 00:01:20, 6.23 m  
 Attached deposits, other at joint from 12 o'clock to 2 o'clock,  
 5% cross-sectional area loss

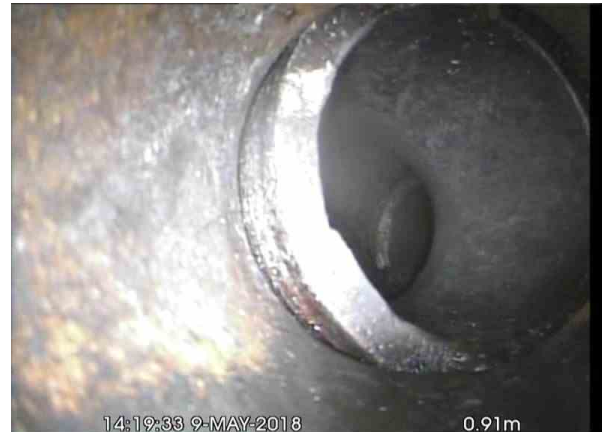
, 00:00:15, 0.90 m  
 Joint displaced, medium

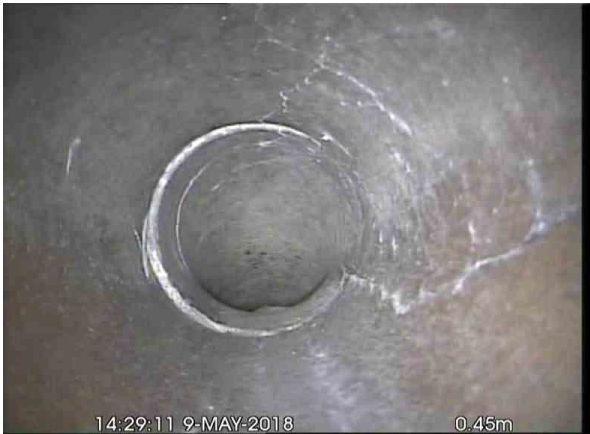
| Section | Inspection Direction | PLR | Client's Job Ref | Contractor's Job Ref |
|---|---|---|---|---|
| 85 | Upstream | | | DIUK-1021 |

| Scale: 1:50 | Position [m] | Code | Observation | MPEG | Photo | Grade |
|---|---|---|---|---|---|---|
| | 0.45 | FLJ | Fracture, longitudinal at joint at 4 o'clock | 00:00:16 | | 3 |

, 00:00:16, 0.45 m  
 Fracture, longitudinal at joint at 4 o'clock

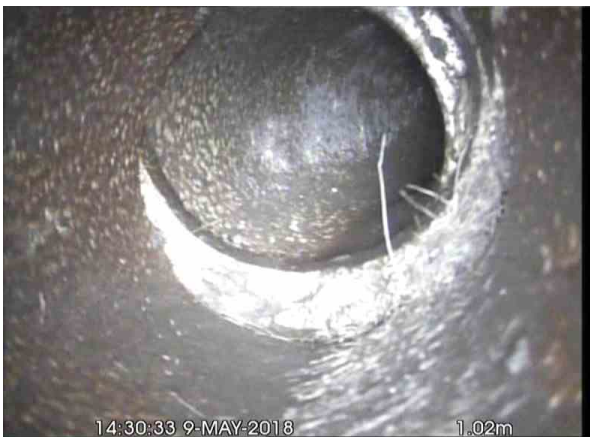
, 00:00:27, 1.02 m  
 Joint displaced, medium

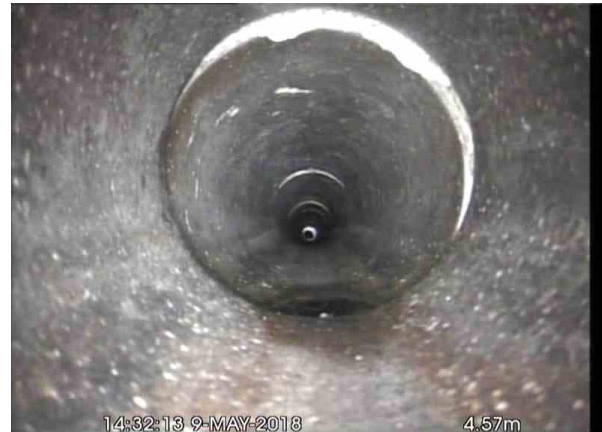
, 00:00:35, 4.57 m  
 Attached deposits, other at joint from 11 o'clock to 2 o'clock,  
 5% cross-sectional area loss

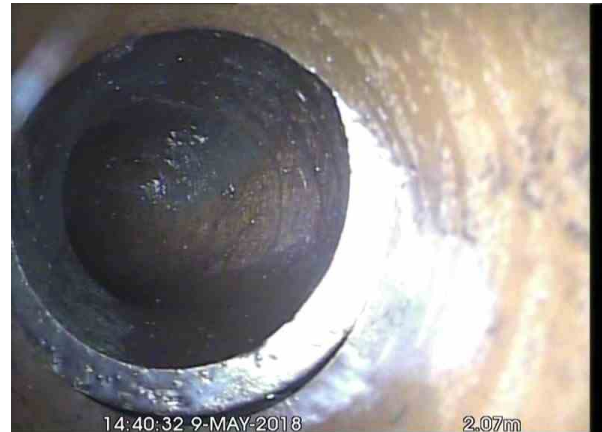
, 00:00:14, 2.07 m  
 Joint displaced, medium

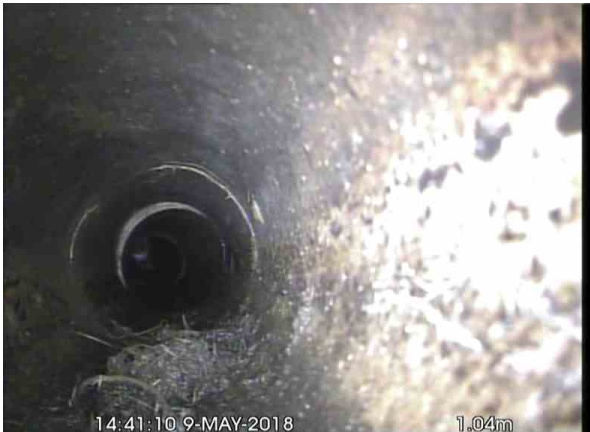
| Section | Inspection Direction | PLR | Client's Job Ref | Contractor's Job Ref |
|---|---|---|---|---|
| 90 | Upstream | | | DIUK-1021 |

, 00:00:05, 1.04 m  
 Roots, mass, 5% cross-sectional area loss

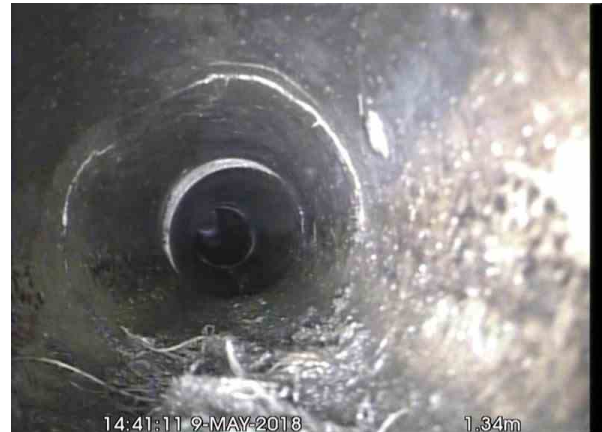
, 00:00:06, 1.34 m  
 Crack, circumferential at joint from 12 o'clock to 12 o'clock

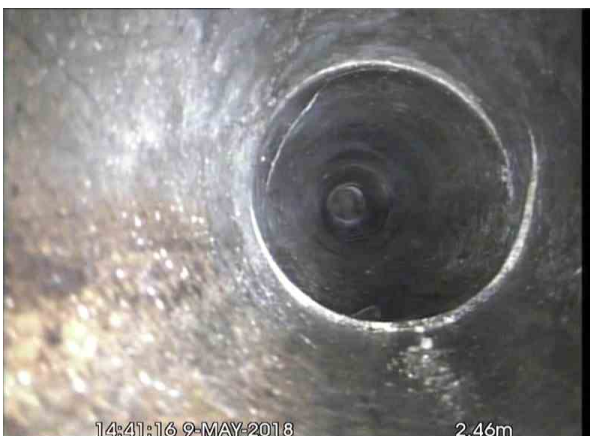
, 00:00:12, 2.46 m  
 Crack, circumferential at joint from 12 o'clock to 12 o'clock

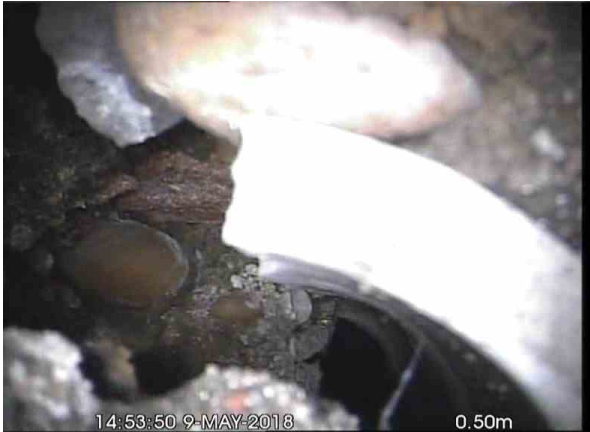
| Section | Inspection Direction | PLR | Client's Job Ref | Contractor's Job Ref |
|---|---|---|---|---|
| 95 | Upstream | | | DIUK-1021 |

, 00:00:10, 0.50 m  
 Collapsed drain or sewer

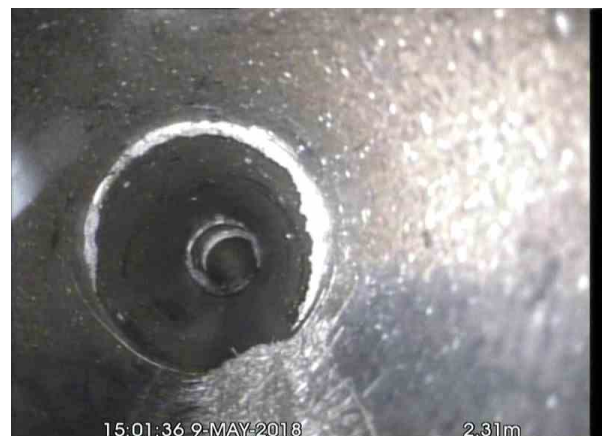
, 00:00:22, 2.31 m  
 Crack, circumferential at joint from 4 o'clock to 8 o'clock

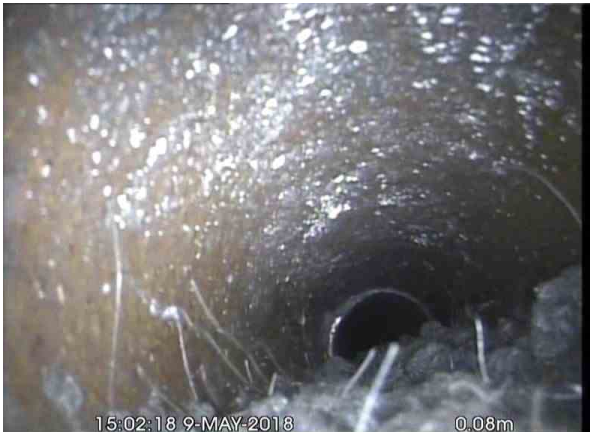
, 00:00:03, 0.02 m  
 Settled deposits, fine, 15% cross-sectional area loss, start

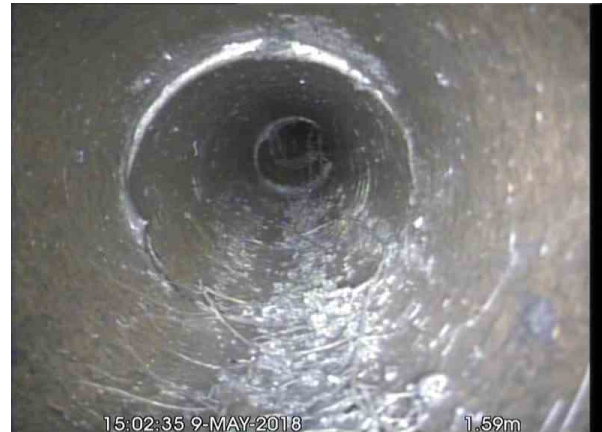
, 00:00:21, 1.59 m  
 Settled deposits, fine, 15% cross-sectional area loss, finish

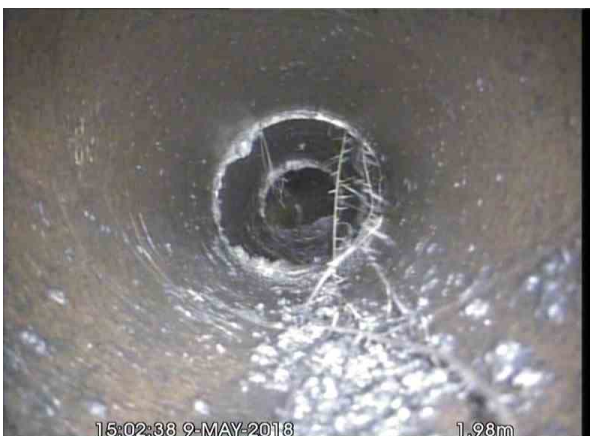
, 00:00:23, 1.98 m  
 Roots, tap at joint

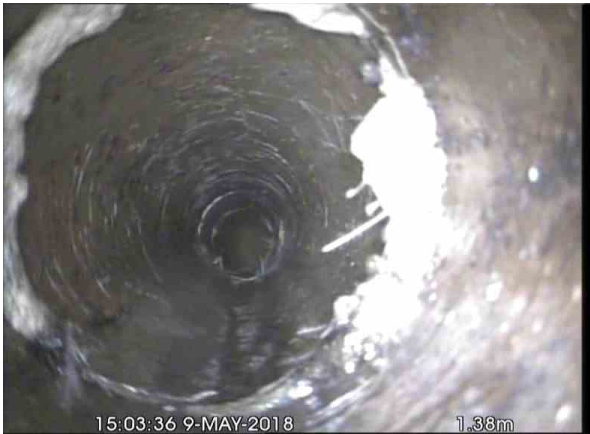
, 00:00:14, 1.38 m  
 Attached deposits, encrustation at joint from 8 o'clock to 5 o'clock, 5% cross-sectional area loss

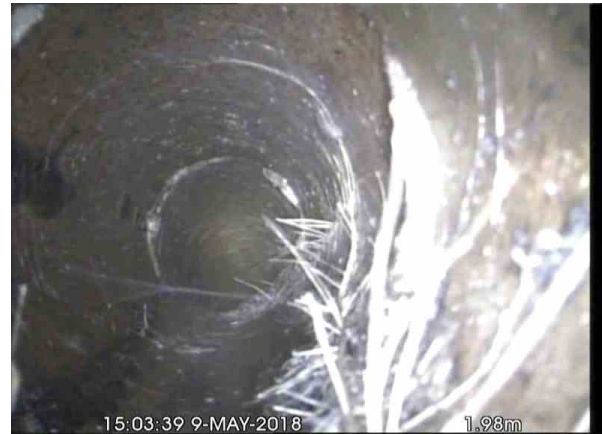
, 00:00:17, 1.98 m  
 Roots, fine at joint

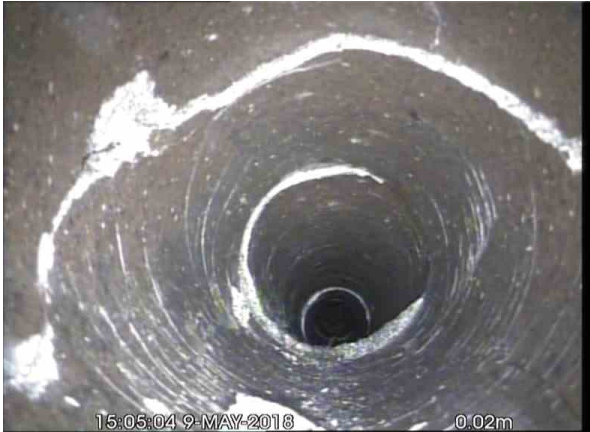
, 00:00:04, 0.02 m  
 Fracture, circumferential at joint from 8 o'clock to 4 o'clock

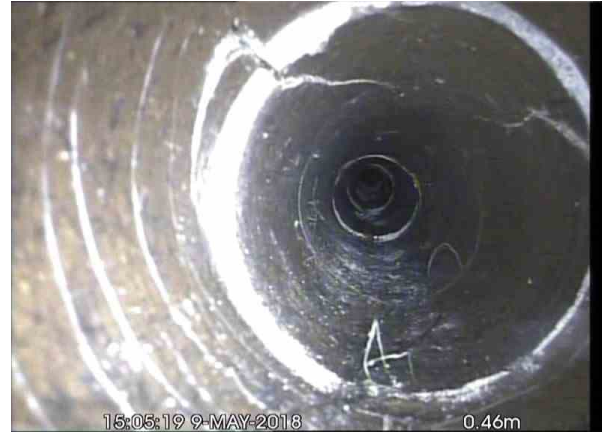
, 00:00:19, 0.46 m  
 Fracture, circumferential at joint from 10 o'clock to 2 o'clock

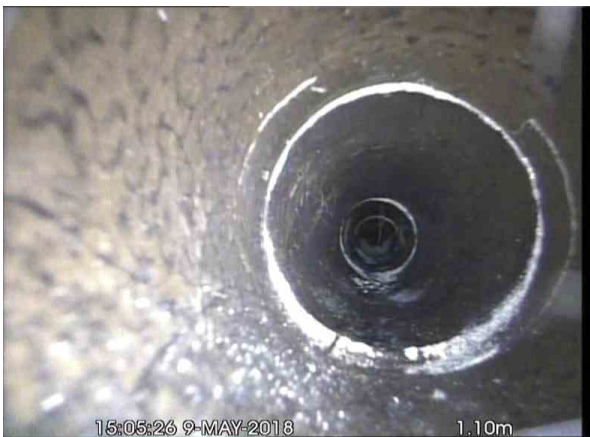
, 00:00:26, 1.10 m  
 Crack, circumferential at joint from 1 o'clock to 11 o'clock

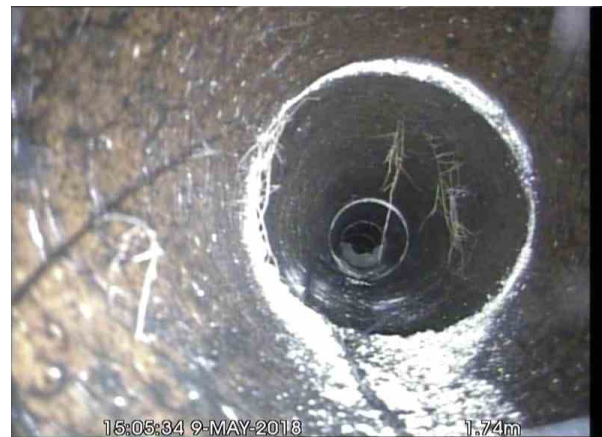
, 00:00:33, 1.74 m  
 Roots, fine at joint

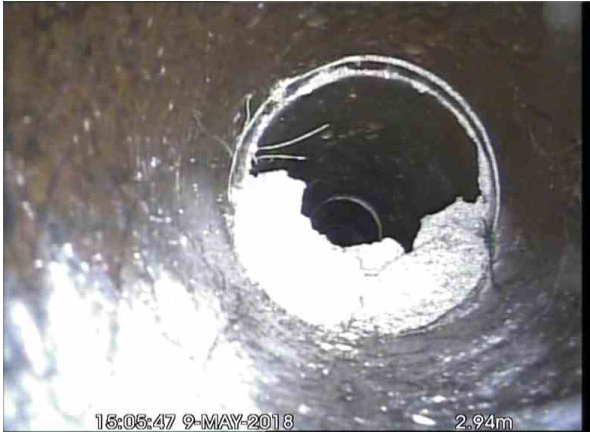
, 00:00:47, 2.94 m  
 Crack, circumferential at joint from 12 o'clock to 12 o'clock

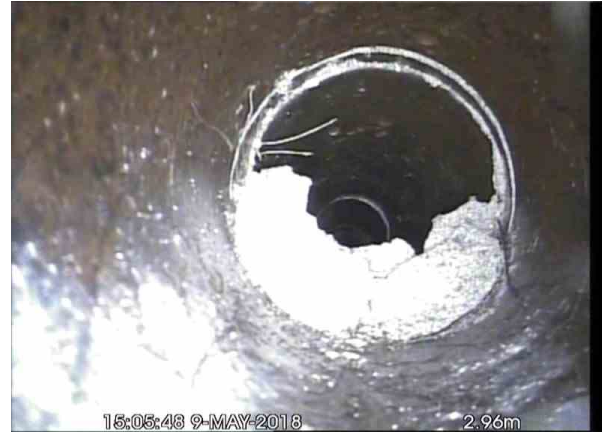
, 00:00:48, 2.96 m  
 Attached deposits, other at joint from 4 o'clock to 8 o'clock,  
 35% cross-sectional area loss

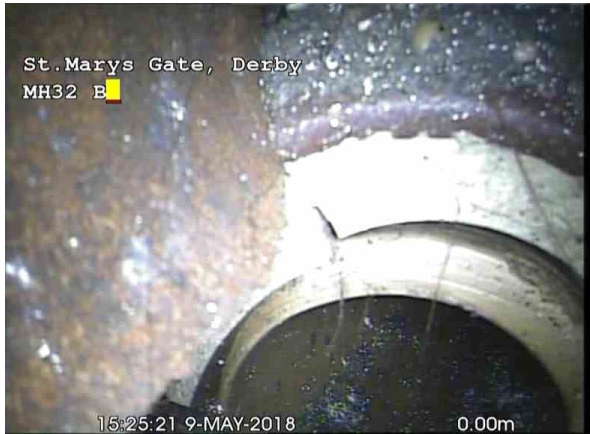
, 00:00:00, 0.15 m  
 Joint displaced, large

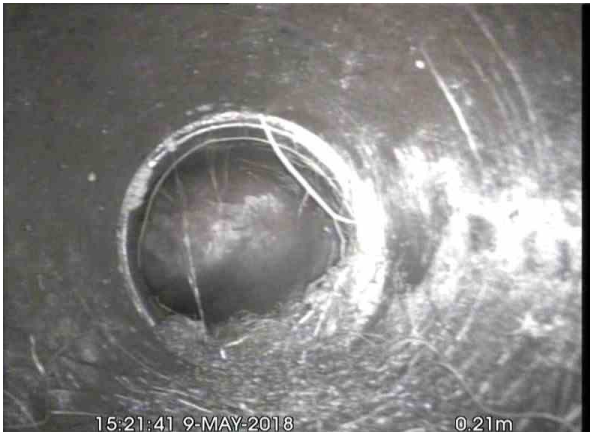
, 00:00:11, 0.21 m  
 Roots, mass at joint, 5% cross-sectional area loss

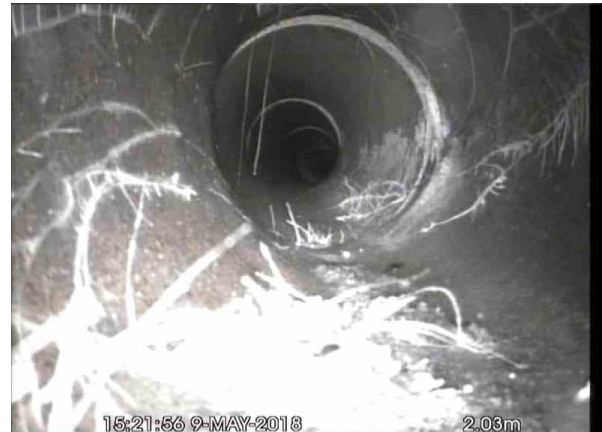
, 00:00:26, 2.03 m  
 Roots, fine at joint

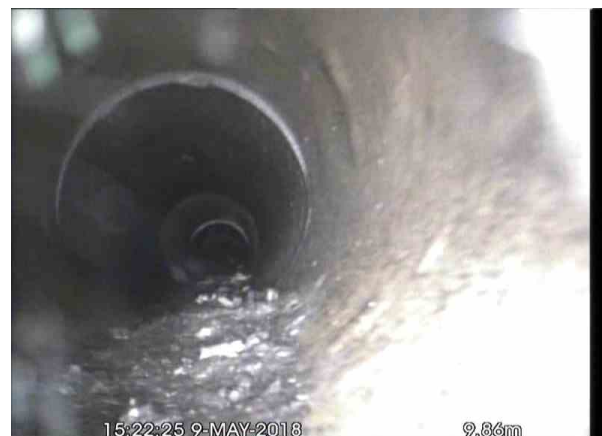
, 00:00:55, 9.86 m  
 Settled deposits, fine, 5% cross-sectional area loss, start

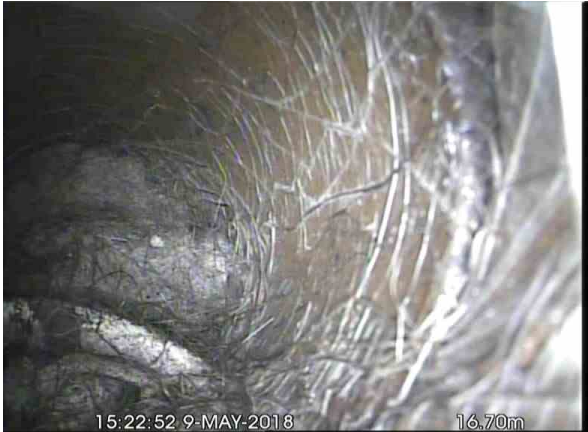
| Section | Inspection Direction | PLR | Client's Job Ref | Contractor's Job Ref |
|---|---|---|---|---|
| 107 | Upstream | | | DIUK-1021 |

, 00:01:21, 16.70 m  
 Collapsed drain or sewer

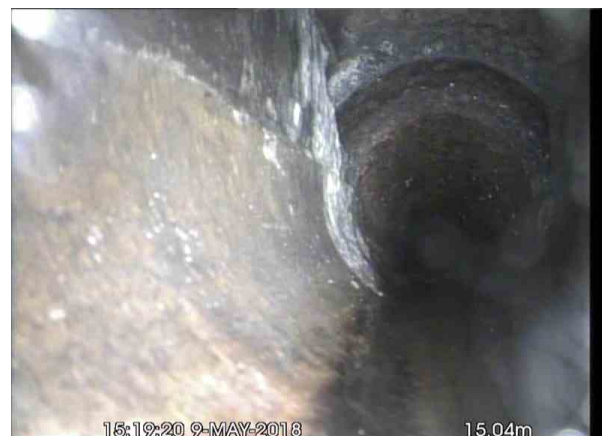
, 00:01:07, 15.04 m  
 General remark, Camera passes through buried MH

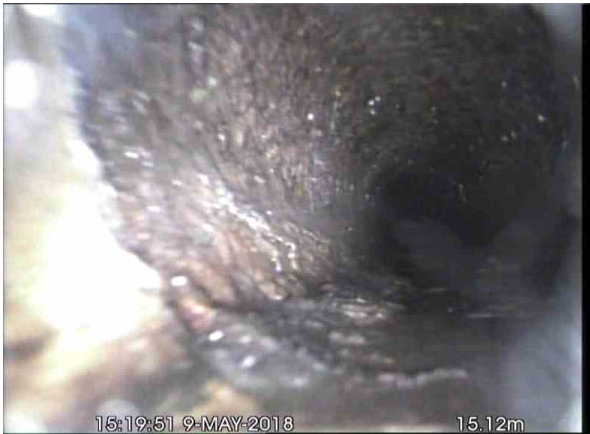
| Section | Inspection Direction | PLR | Client's Job Ref | Contractor's Job Ref |
|---|---|---|---|---|
| 109 | Downstream | | | DIUK-1021 |

, 00:01:38, 15.12 m  
 Material changes to cast iron

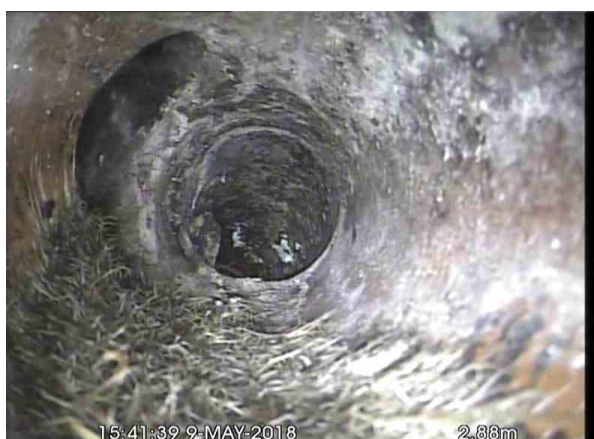
, 00:00:22, 2.88 m  
 Roots, mass, 5% cross-sectional area loss

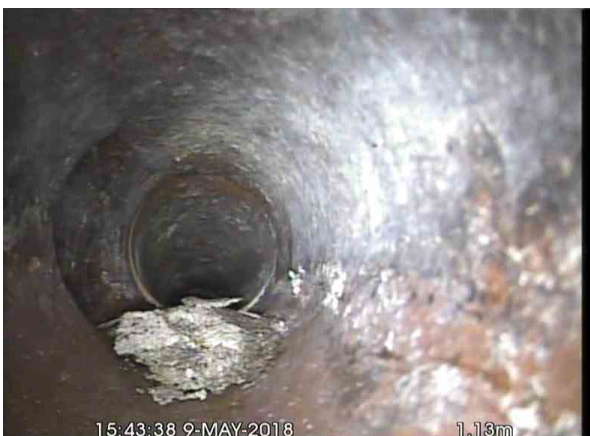
, 00:00:13, 1.13 m  
 Settled deposits, other at joint, 5% cross-sectional area loss

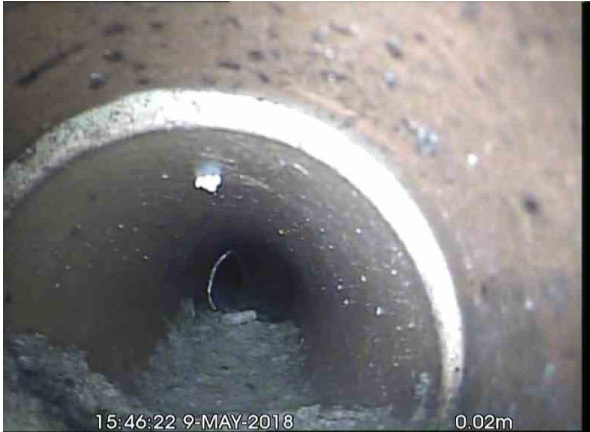
| Section | Inspection Direction | PLR | Client's Job Ref | Contractor's Job Ref |
|---|---|---|---|---|
| 116 | Upstream | | | DIUK-1021 |

, 00:00:03, 0.02 m  
 Settled deposits, fine, 5% cross-sectional area loss, start
