**Project Name:** DIUK-1021\_02 St Marys Gate, Derby CCTV Report  
**Job Status:** Complete  
**Project Date:** 10/05/2018  
**Project Standard:** MSCC4 Sewers & Drainage GB (SRM4 Scoring)

# Drain Inspect UK

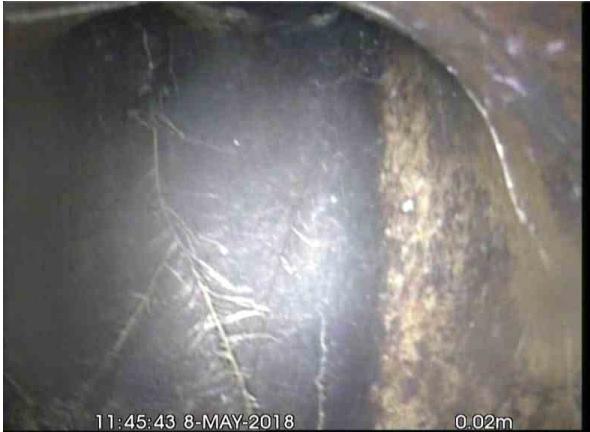
, 00:00:04, 0.02 m  
 Roots, fine

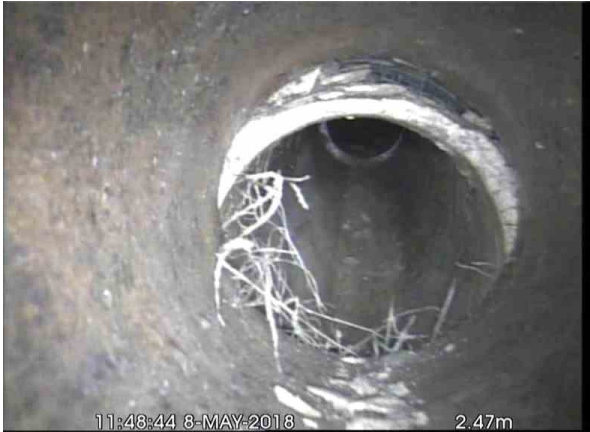
, 00:00:22, 2.47 m  
 Open joint, medium

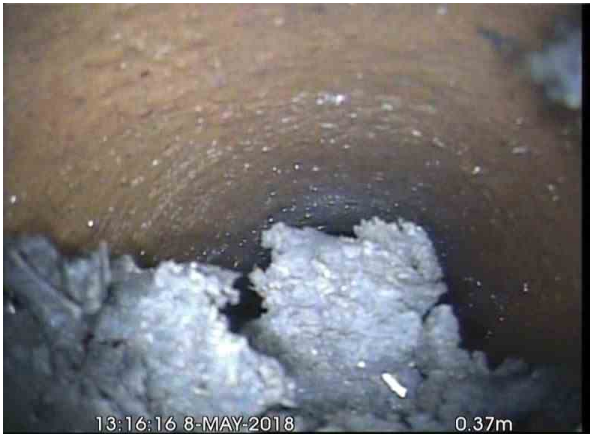
| Section | Inspection Direction | PLR | Client's Job Ref | Contractor's Job Ref |
|---|---|---|---|---|
| 40 | Upstream | | | DIUK-1021 |

, 00:00:19, 0.37 m  
 Settled deposits, fine, 80% cross-sectional area loss

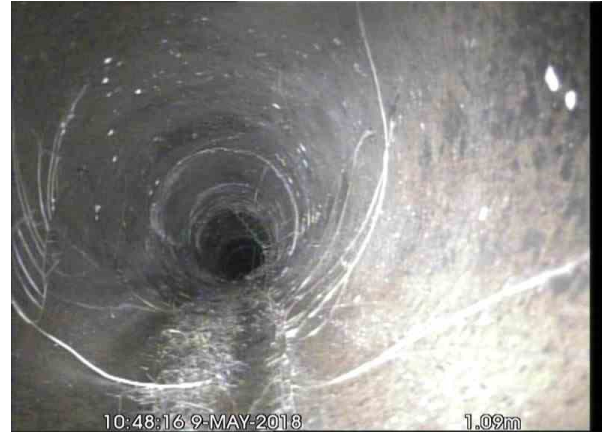
, 00:00:13, 1.09 m  
 Roots, mass, 5% cross-sectional area loss, start

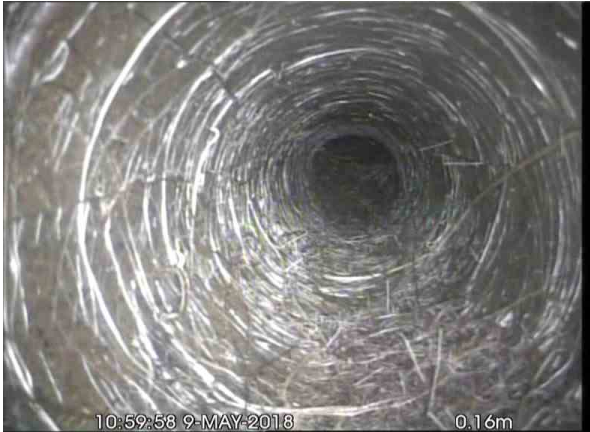
, 00:00:03, 0.16 m  
 Roots, mass, 5% cross-sectional area loss, start

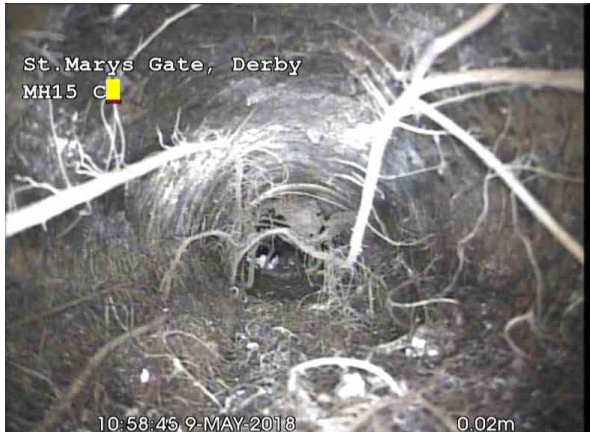
, 00:00:01, 0.02 m  
 Roots, mass, 15% cross-sectional area loss, start

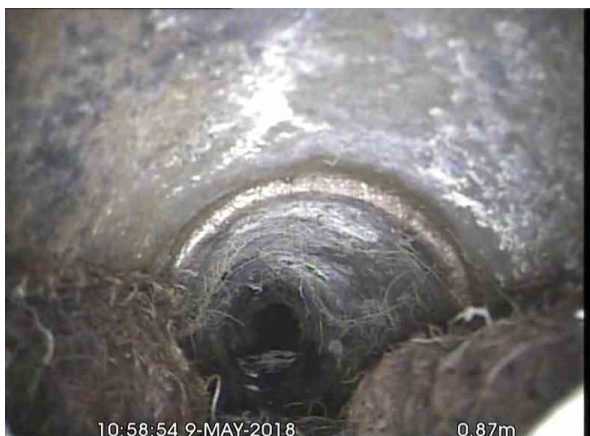
, 00:00:10, 0.87 m  
 Roots, mass, 15% cross-sectional area loss, finish

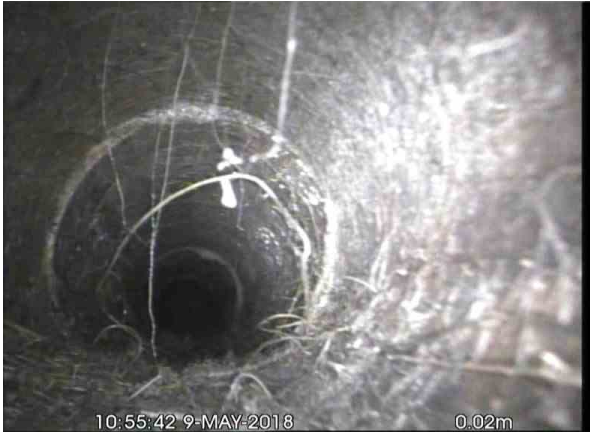
, 00:00:04, 0.02 m  
 Roots, mass, 5% cross-sectional area loss, start

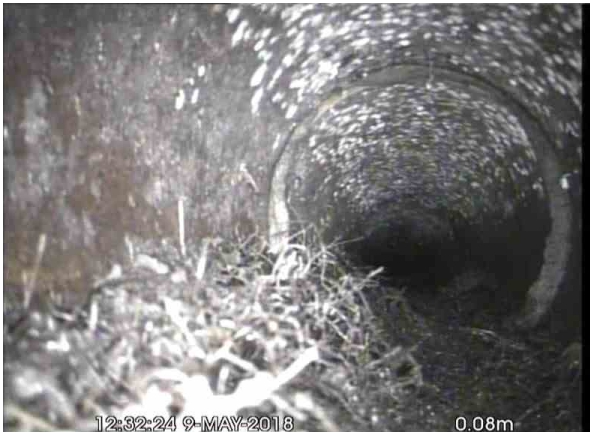
, 00:00:06, 0.08 m  
 Roots, mass, 10% cross-sectional area loss, start

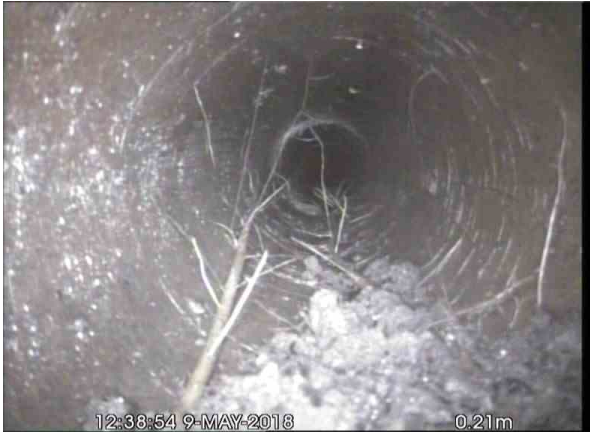
, 00:00:14, 0.21 m  
 Roots, tap

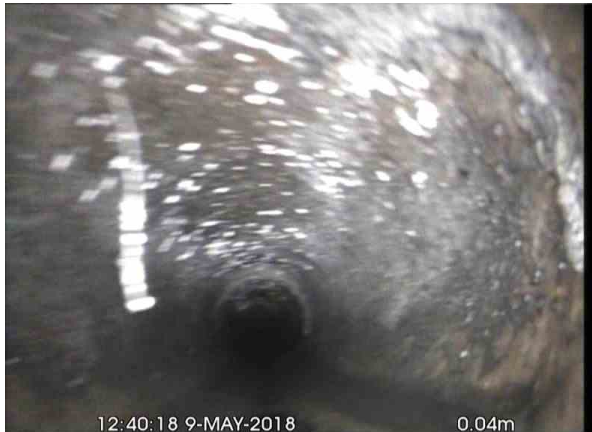
, 00:00:05, 0.04 m  
 Size changes, new size(s), 100mm high

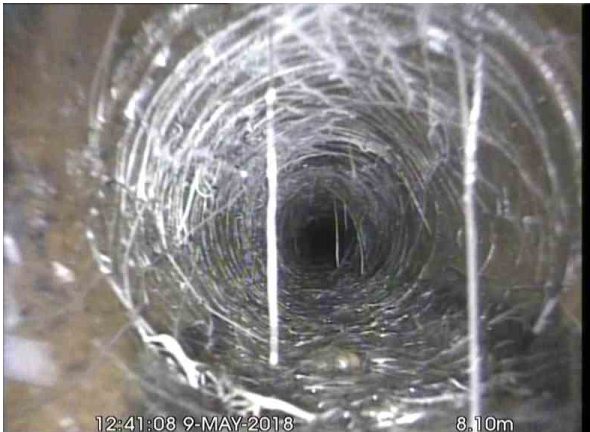
, 00:00:55, 8.10 m  
 Roots, mass, 5% cross-sectional area loss, start

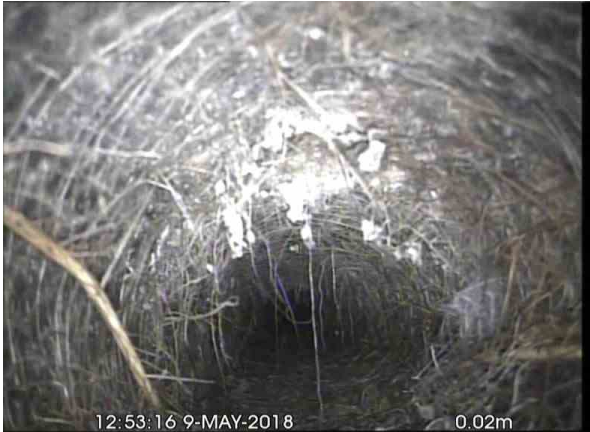
, 00:00:09, 0.02 m  
 Roots, mass, 15% cross-sectional area loss, start

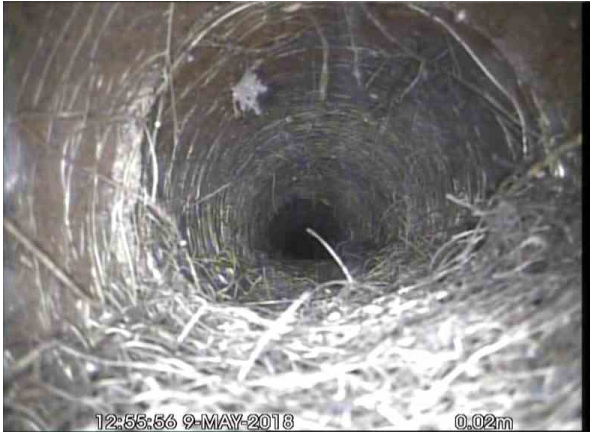
, 00:00:04, 0.02 m  
 Roots, mass, 15% cross-sectional area loss, start

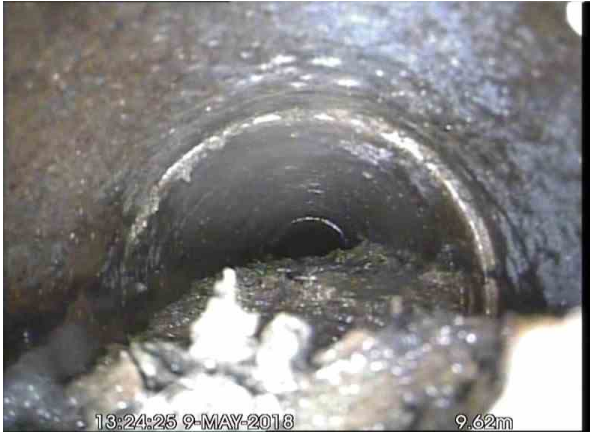
, 00:01:51, 9.62 m  
 Survey abandoned, Unable to pass debris

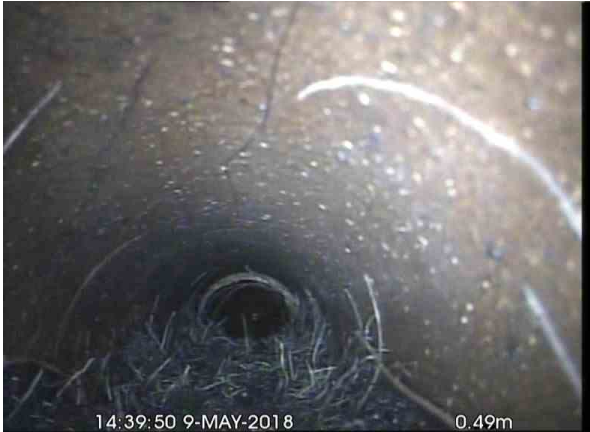
| Section | Inspection Direction | PLR | Client's Job Ref | Contractor's Job Ref |
|---|---|---|---|---|
| 88 | Upstream | | | DIUK-1021 |

, 00:00:07, 0.49 m  
 Roots, mass, 10% cross-sectional area loss, start

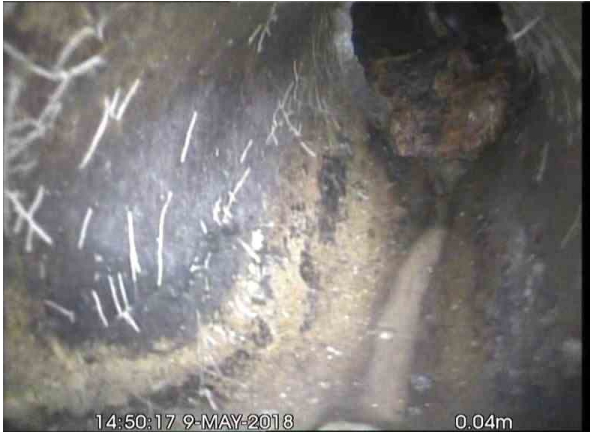
, 00:00:20, 0.04 m  
 Attached deposits, other from 4 o'clock to 8 o'clock, 20%  
 cross-sectional area loss

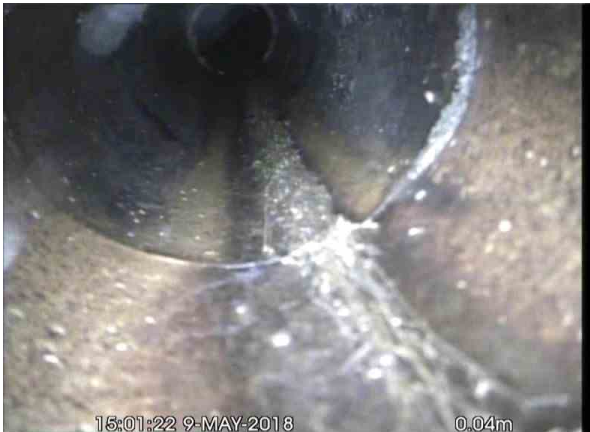
, 00:00:08, 0.04 m  
 Roots, mass, 5% cross-sectional area loss, start

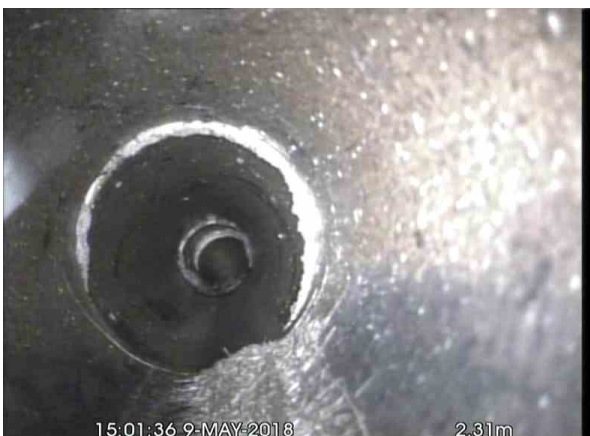
, 00:00:22, 2.31 m  
 Roots, mass, 5% cross-sectional area loss, finish

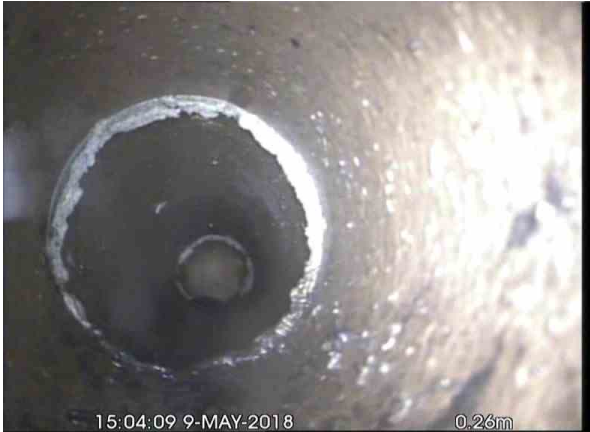
, 00:00:09, 0.26 m  
 Attached deposits, other at joint from 12 o'clock to 12 o'clock,  
 5% cross-sectional area loss

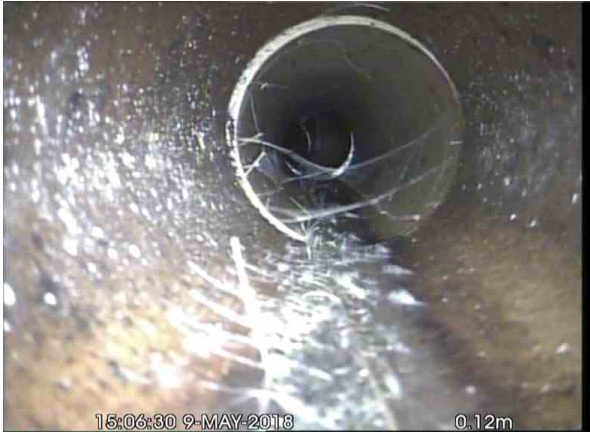
, 00:00:04, 0.12 m  
 Roots, mass, 5% cross-sectional area loss, start

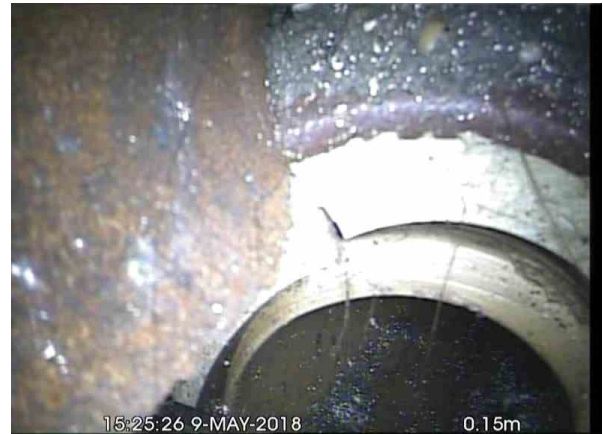
, 00:00:00, 0.15 m  
 Survey abandoned, Unable to pass displaced joint

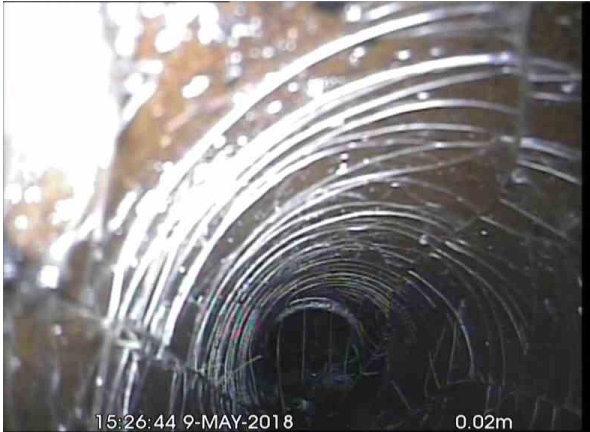
, 00:00:02, 0.02 m  
 Roots, mass, 5% cross-sectional area loss, start

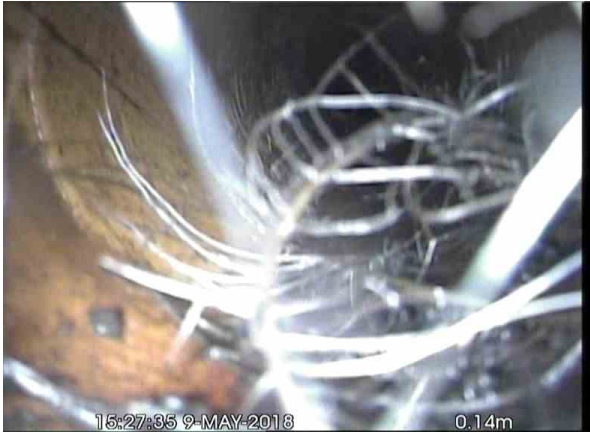
, 00:00:04, 0.14 m  
 Roots, mass, 5% cross-sectional area loss, start

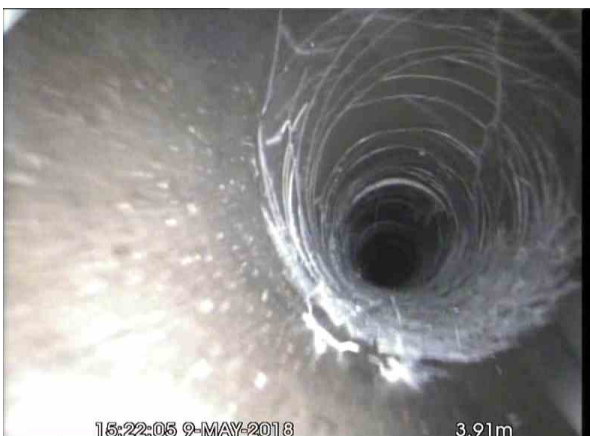
, 00:00:35, 3.91 m  
 Roots, mass, 5% cross-sectional area loss, start

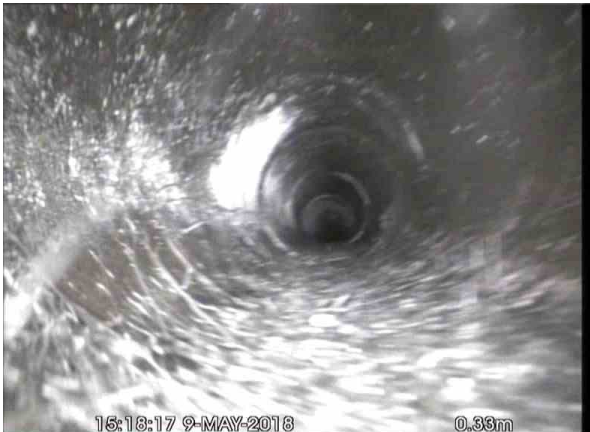
| Section | Inspection Direction | PLR | Client's Job Ref | Contractor's Job Ref |
|---|---|---|---|---|
| 109 | Downstream | | | DIUK-1021 |

, 00:00:04, 0.33 m  
 Roots, mass, 5% cross-sectional area loss, start

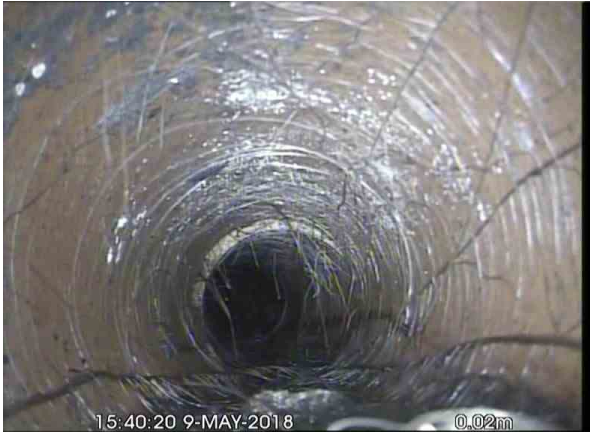
| Section | Inspection Direction | PLR | Client's Job Ref | Contractor's Job Ref |
|---|---|---|---|---|
| 110 | Upstream | | | DIUK-1021 |

, 00:00:04, 0.02 m  
 Roots, mass, 5% cross-sectional area loss, start

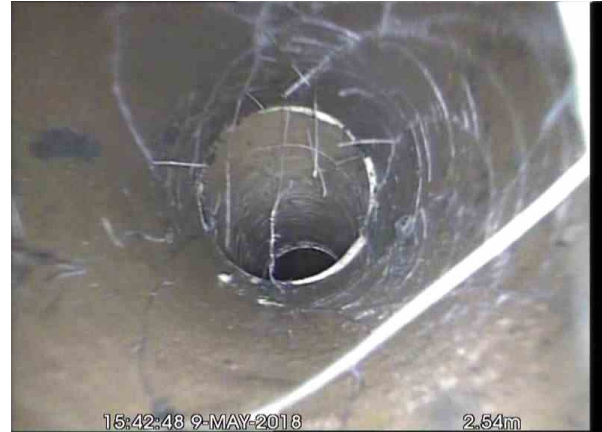
, 00:00:15, 2.54 m  
 Roots, fine at joint

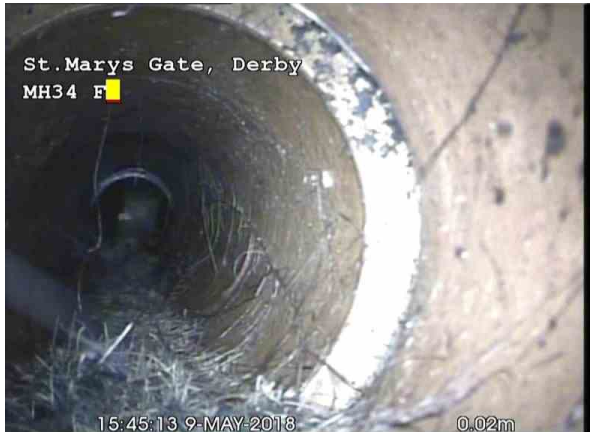
| Section | Inspection Direction | PLR | Client's Job Ref | Contractor's Job Ref |
|---|---|---|---|---|
| 115 | Upstream | | | DIUK-1021 |

, 00:00:02, 0.02 m  
 Roots, mass, 5% cross-sectional area loss, start

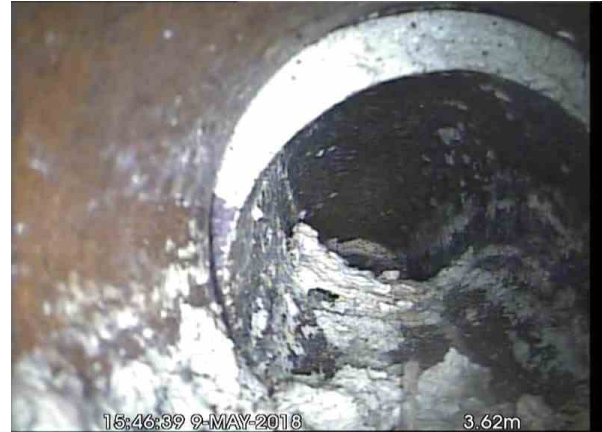
, 00:00:20, 3.62 m  
 Survey abandoned, Unable to pass displaced joint

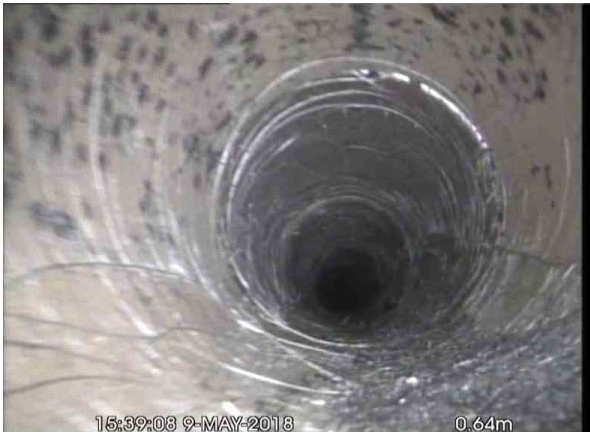
| Section | Inspection Direction | PLR | Client's Job Ref | Contractor's Job Ref |
|---|---|---|---|---|
| 117 | Downstream | | | DIUK-1021 |

, 00:00:08, 0.64 m  
 Roots, fine, start
